2024

BIOLOGY

ANNUAL REPORT

Central Arizona Water Conservation District
Water Transmission Division

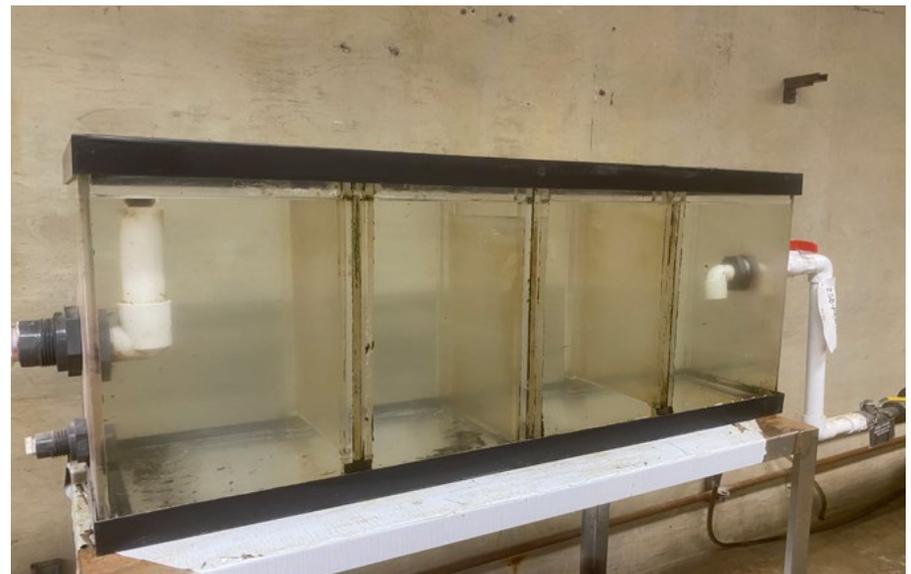
QUAGGA MUSSEL SHELLS AT THE GLENDALE PYRAMID PEAK WTP

In June 2024, Pyramid Peak Water Treatment Plant (City of Glendale) notified CAP that excessive quagga shells were backwashed from their system and had filled several dumpsters. Since the turnout had been cleaned just six months prior, the source of the shells was unknown. CAP investigated the potential causes, including underwater video inspection of the upstream pool. There was no visible source of the shells, although the timing of the event suggests that shell debris in Waddell Canal may have been carried downstream and followed flow into the turnout.

In 2025, we will continue to monitor quagga infestation and growth rates in bio-boxes, trash racks, and MWP cooling water systems. We will also continue to rely on maintenance personnel and stakeholders to communicate any issues and address those problems as they arise. Effectiveness of the chemical injection system will also continued to be monitored. We will also continue to work with the City of Glendale to pinpoint the source of quagga shells that impacted the plant in 2024.

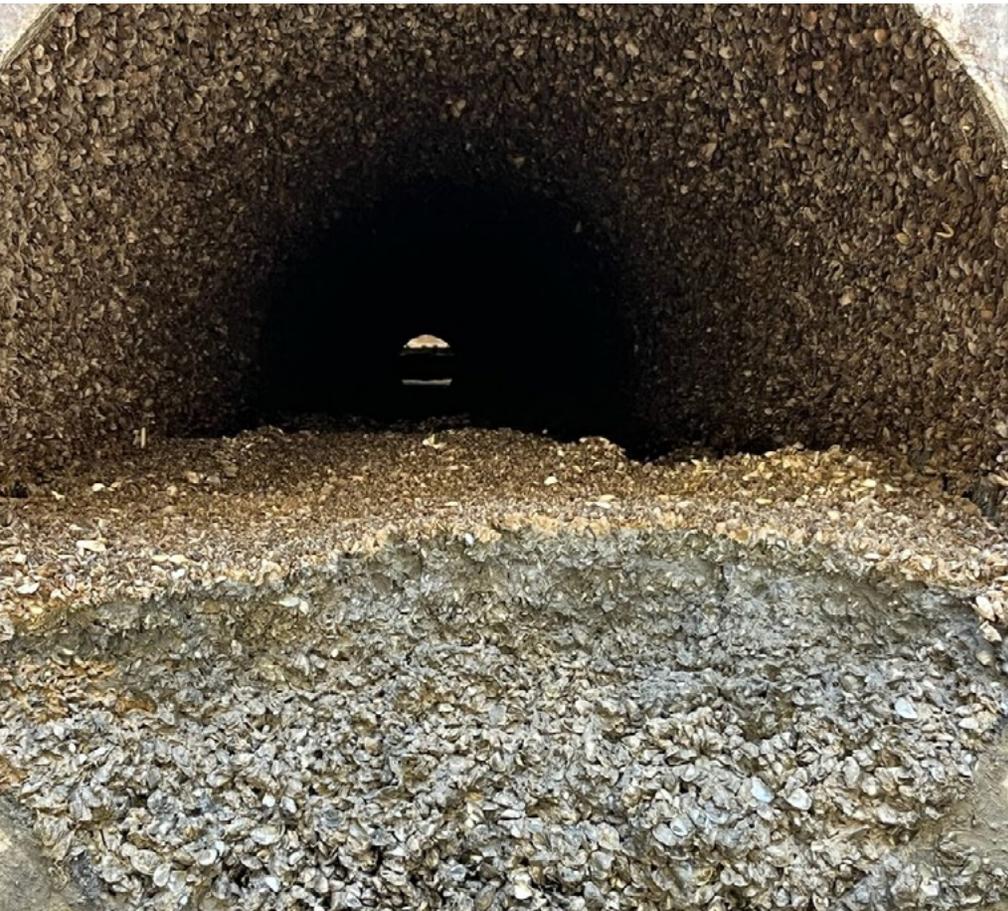
In May 2024, flow meters at PXATO were not properly functioning. Upon further inspection, quagga mussel shells had accumulated to an unusually high level in the turnout barrel (see photo page 8). Divers were contracted to clean the turnout and restore functionality to the flow meter. The build-up likely occurred over a number of years as a result of quagga discharged from Lake Pleasant and the extremely slow water flow moving through the turnout. More frequent turnout inspections have been recommended to avoid the excessive build-up in the future.

QUAGGA ATTACHMENT AND SHELL DEBRIS AT PXATO

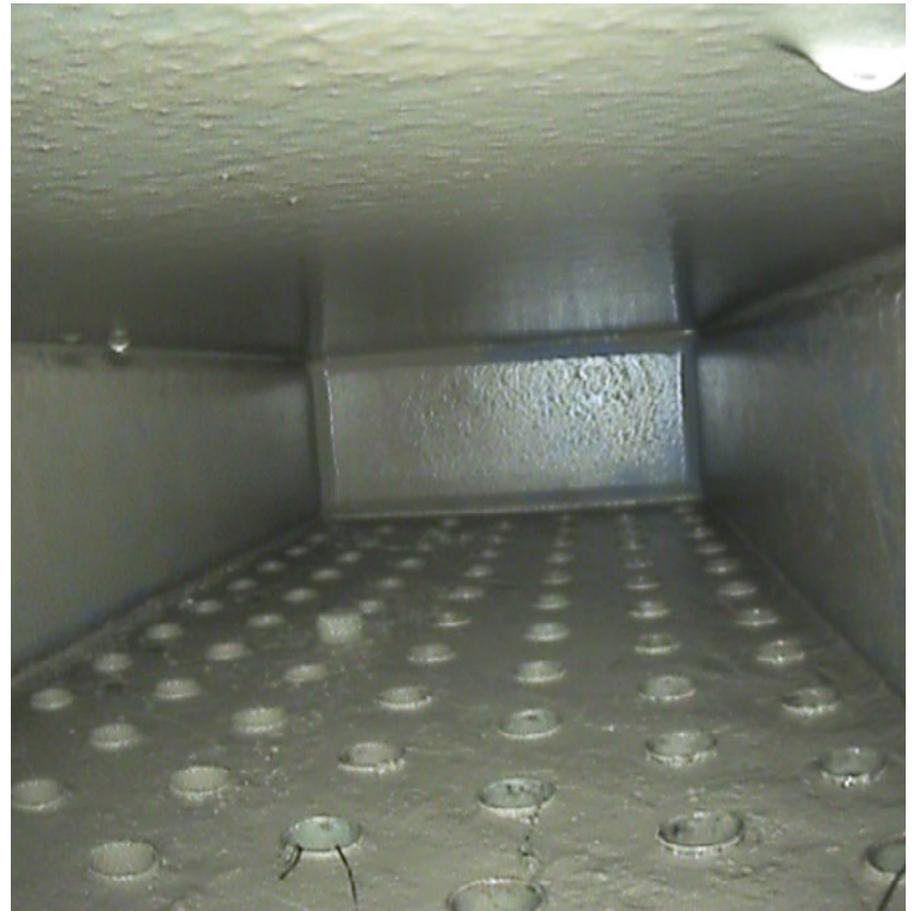
Videoscope evaluations of the MWP unit cooling systems showed that the chemical treatment system, which was installed in 2021, has continued to reduce and/or eliminate quagga and colonial hydroids in this critical infrastructure. Coolers were inspected in late June 2024 and only Units 3 and 6 had visible quagga. Unit 3 had just a small pocket of quagga that appeared to be dead. Although Unit 6 has not been cleaned since 2019 (prior to treatment), only a light infestation was observed. No hydroid were observed in any of the six unit coolers. Prior to treatment, unit coolers were disassembled and power washed on a regular basis at a considerable cost. The relatively inexpensive treatment has eliminated the need to clean the coolers and there have been no forced outages related to unit overheating since the program began in 2021. Due to the effective treatment at 0.75 ppm, dosage was reduced in June 2024 to 0.5 ppm for all units.

UNIT 1 COOLER AT MWP AFTER 30 MONTHS OF TREATMENT WITH EARTHTEC.

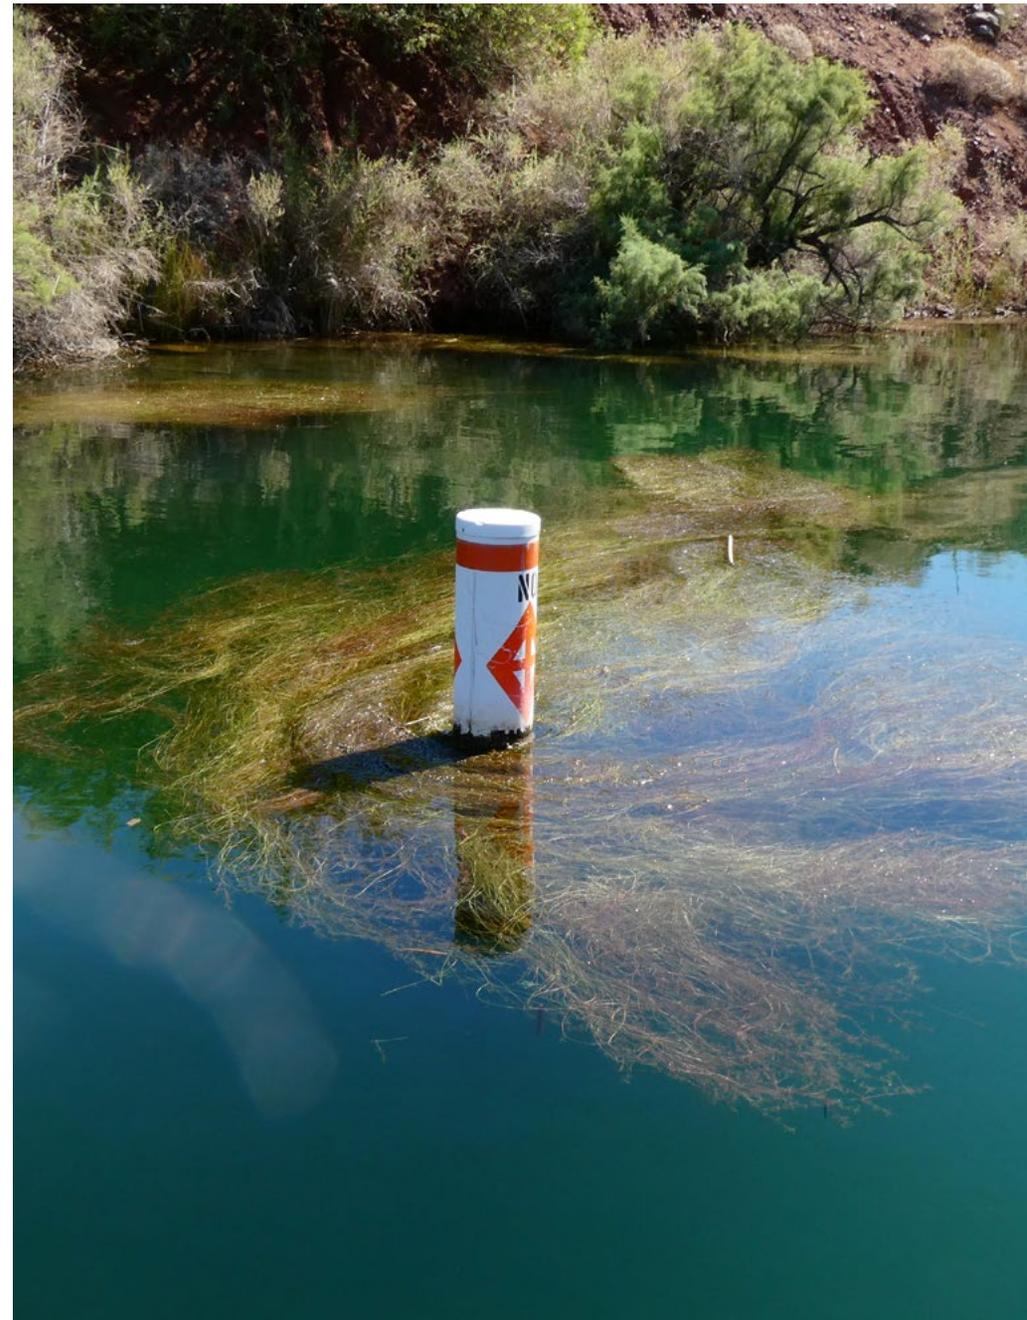
SMALL MATS OF VEGETATION WITHIN THE CAP INTAKE CHANNEL IN 2024.

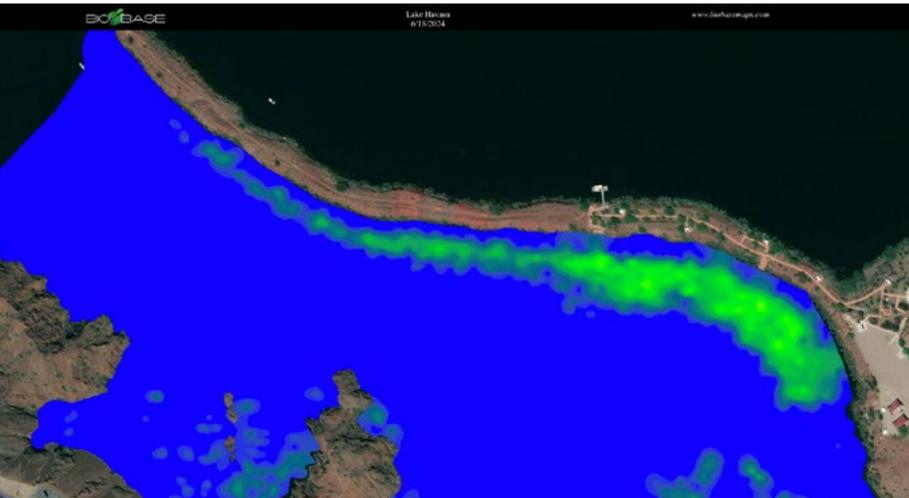
MODERATE WEED GROWTH WAS PRESENT PRIOR TO TREATMENT IN JUNE 2024.

The 2023 Alamo Lake releases caused extremely high levels of turbidity which prevented aquatic weed growth in the CAP intake channel. The effects of that high turbidity were still evident in 2024, as mapping of vegetation growth showed only approximately 20% of what is typically measured. Regardless, the amount of growth still warranted an herbicide treatment. Granular herbicide (Aquathol Super-K) was applied in deeper water to control spiny and southern naiad, while liquid herbicide (Cascade) was applied in shallow water to control pondweed species. Both treatments were extremely effective in nearly eliminating the existing vegetation and minimizing future growth.

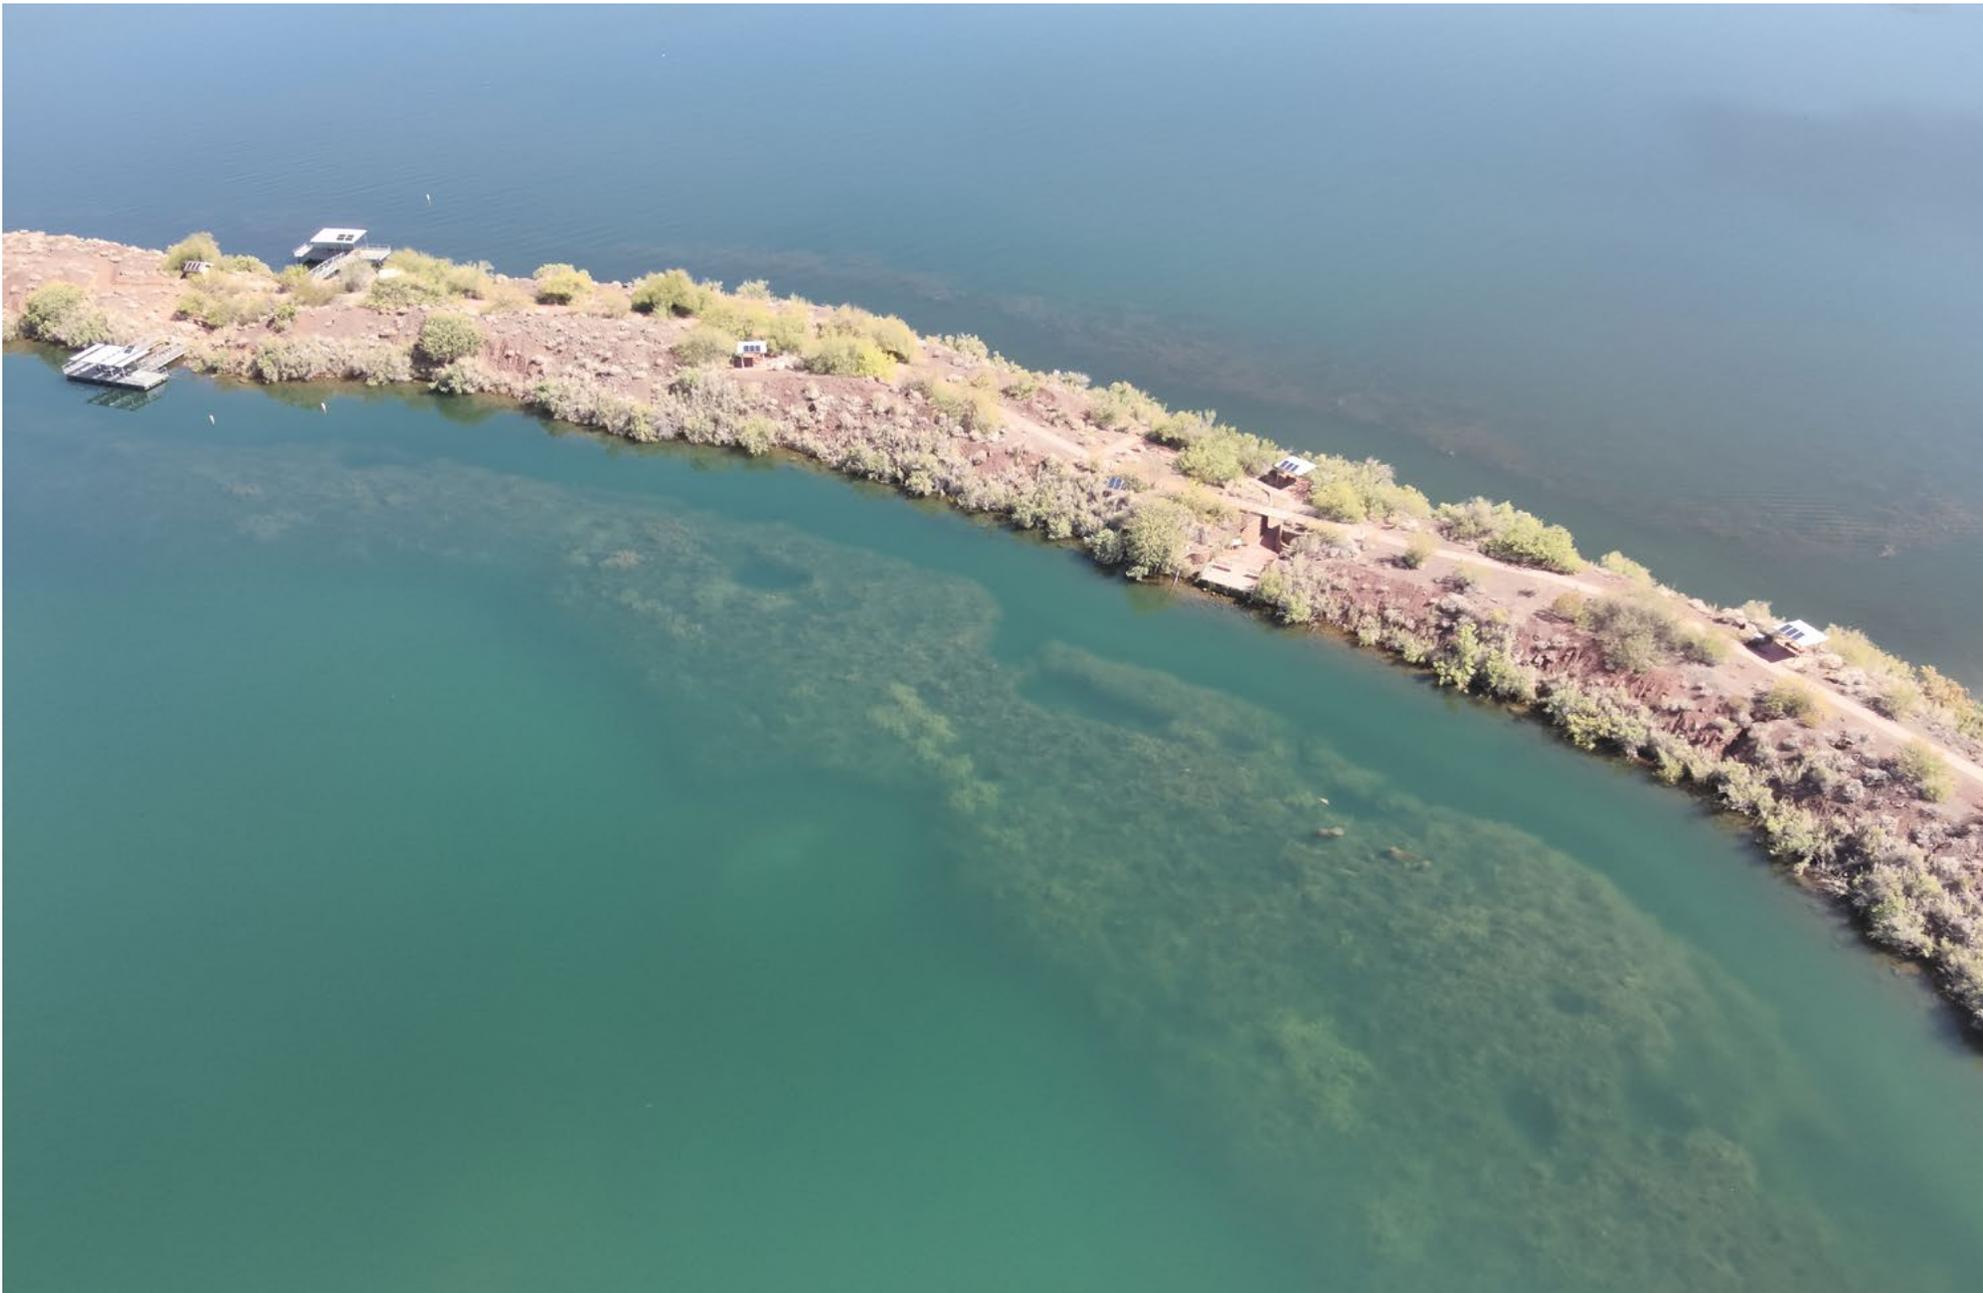
DRONE PHOTO OF VEGETATION GROWTH WITHIN MWP INTAKE CHANNEL IN PRIOR TO TREATMENT IN JUNE 2024.

Monthly mapping of the intake channel will be conducted in 2025 to continue the long-term data set. CAP will replicate the herbicide treatment in 2025, targeting specific areas of heavy growth. The treatment will be completed in June, prior to the weeds reaching the water surface. Pre- and post-treatment vegetation coverage and plant height will be mapped bi-weekly to evaluate the effectiveness of the treatment.

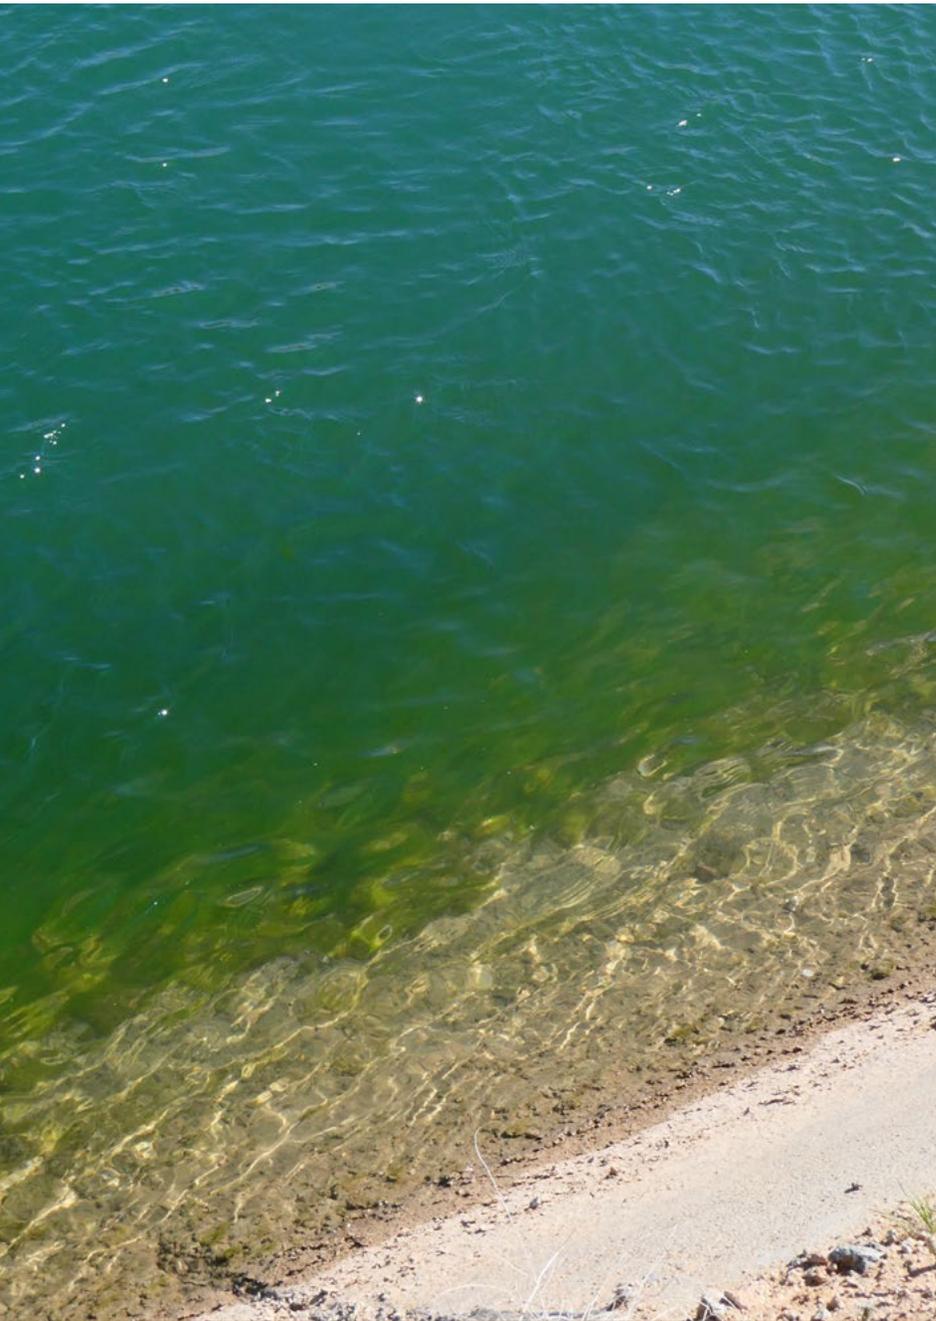
FILAMENTOUS ALGAE GROWTH IN POOL 2 IN APRIL 2024

Filamentous algae was problematic in the western portion of the aqueduct during spring. CAP Operations indicated that they were not able to "push" enough water through a section of canal between BSH and LHQ (Pools 1 and 2) without overtopping the liner. Upon inspection, there was significant growth of filamentous algae just downstream of Cunningham Siphon in Pool 2. Although the growth did not appear to be atypical compared to previous years, it may have been enough to create excessive friction and slow water flow. The relatively heavy growth extended approximately 5 miles downstream. Despite the heavy growth, downstream pumping plants experienced relatively minor issues related to floating algae mats.

Aqueduct crews and other field personnel will visually monitor the system for growth of rooted aquatic vegetation, filamentous algae, and Cymbella. Any problematic growth will be communicated to CAP maintenance personnel and stakeholders. Although grass carp do not prefer algae, stocking in 2025 will be targeted at Pool 2 in an attempt to provide some level of biological control on the algae issue.

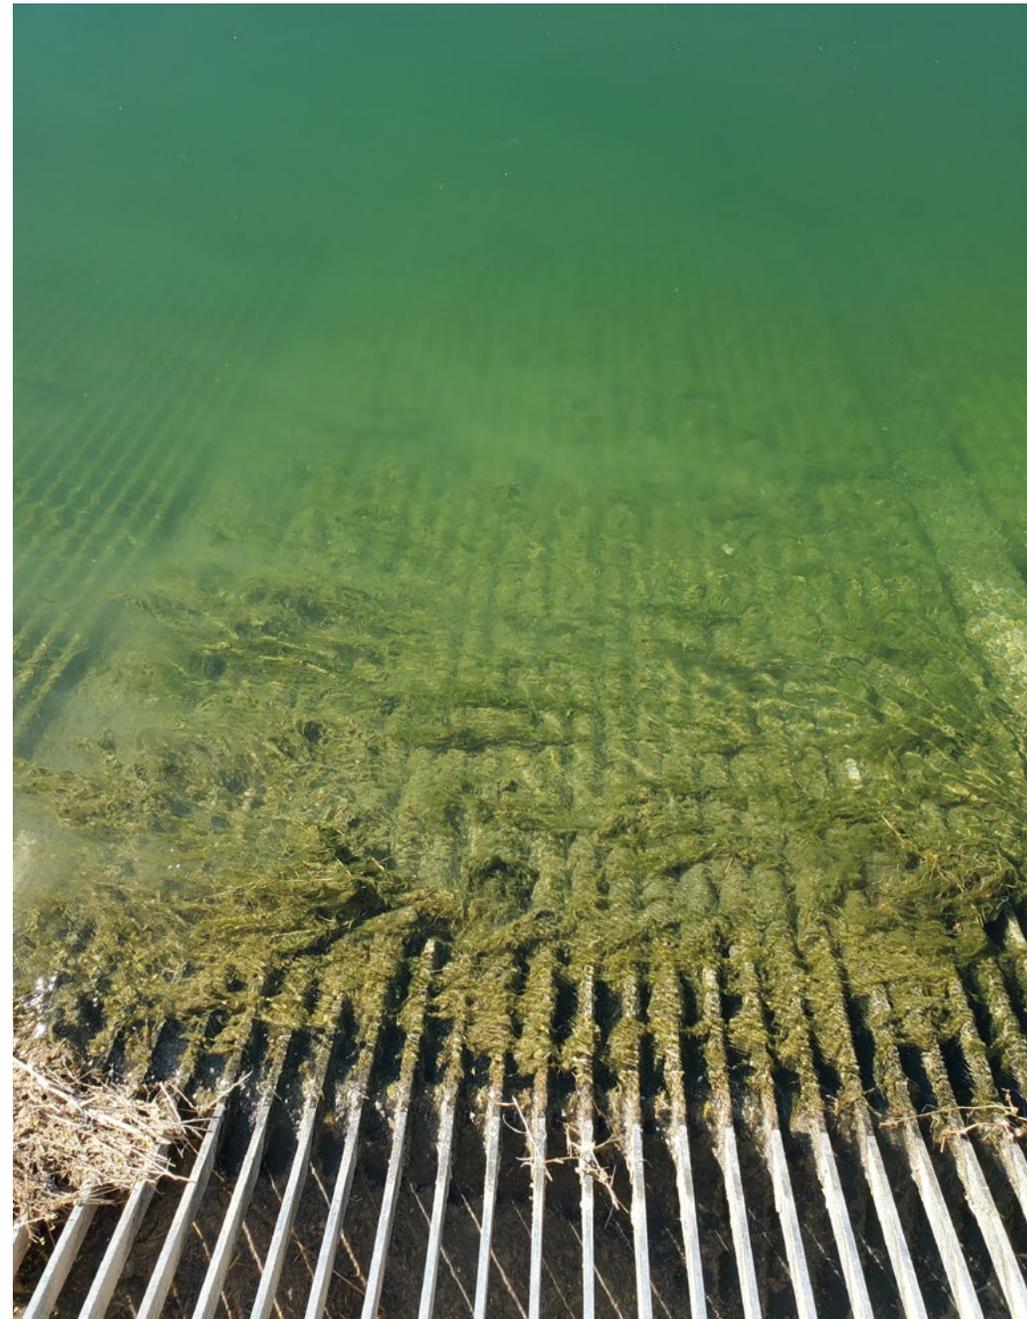
FILAMENTOUS ALGAE CAN CLOG TURNOUTS WHEN IT DETACHES FROM THE CANAL LINER

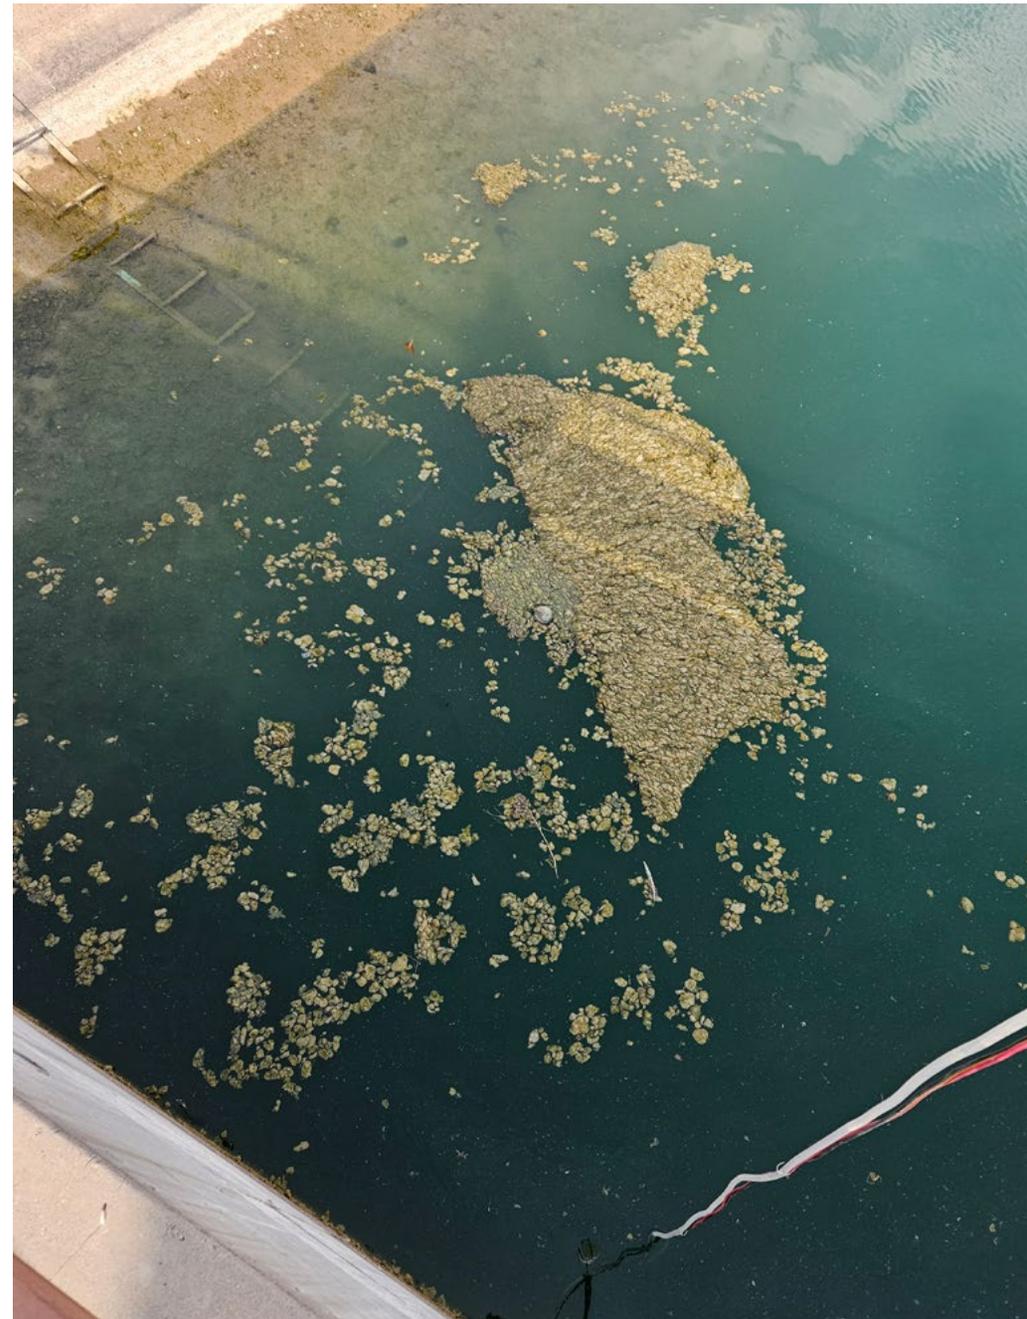
Although there were occasional reports of rock snot in the canal during 2024, there were no significant blooms observed. In February, rock snot growth was noted downstream of SGL on turnout intake grates. In July, floating Cymbella was observed in the southern portion of the system, especially near SXV. There were no impacts reported by stakeholders.

CYMBELLA AT SXV IN JULY 2024.

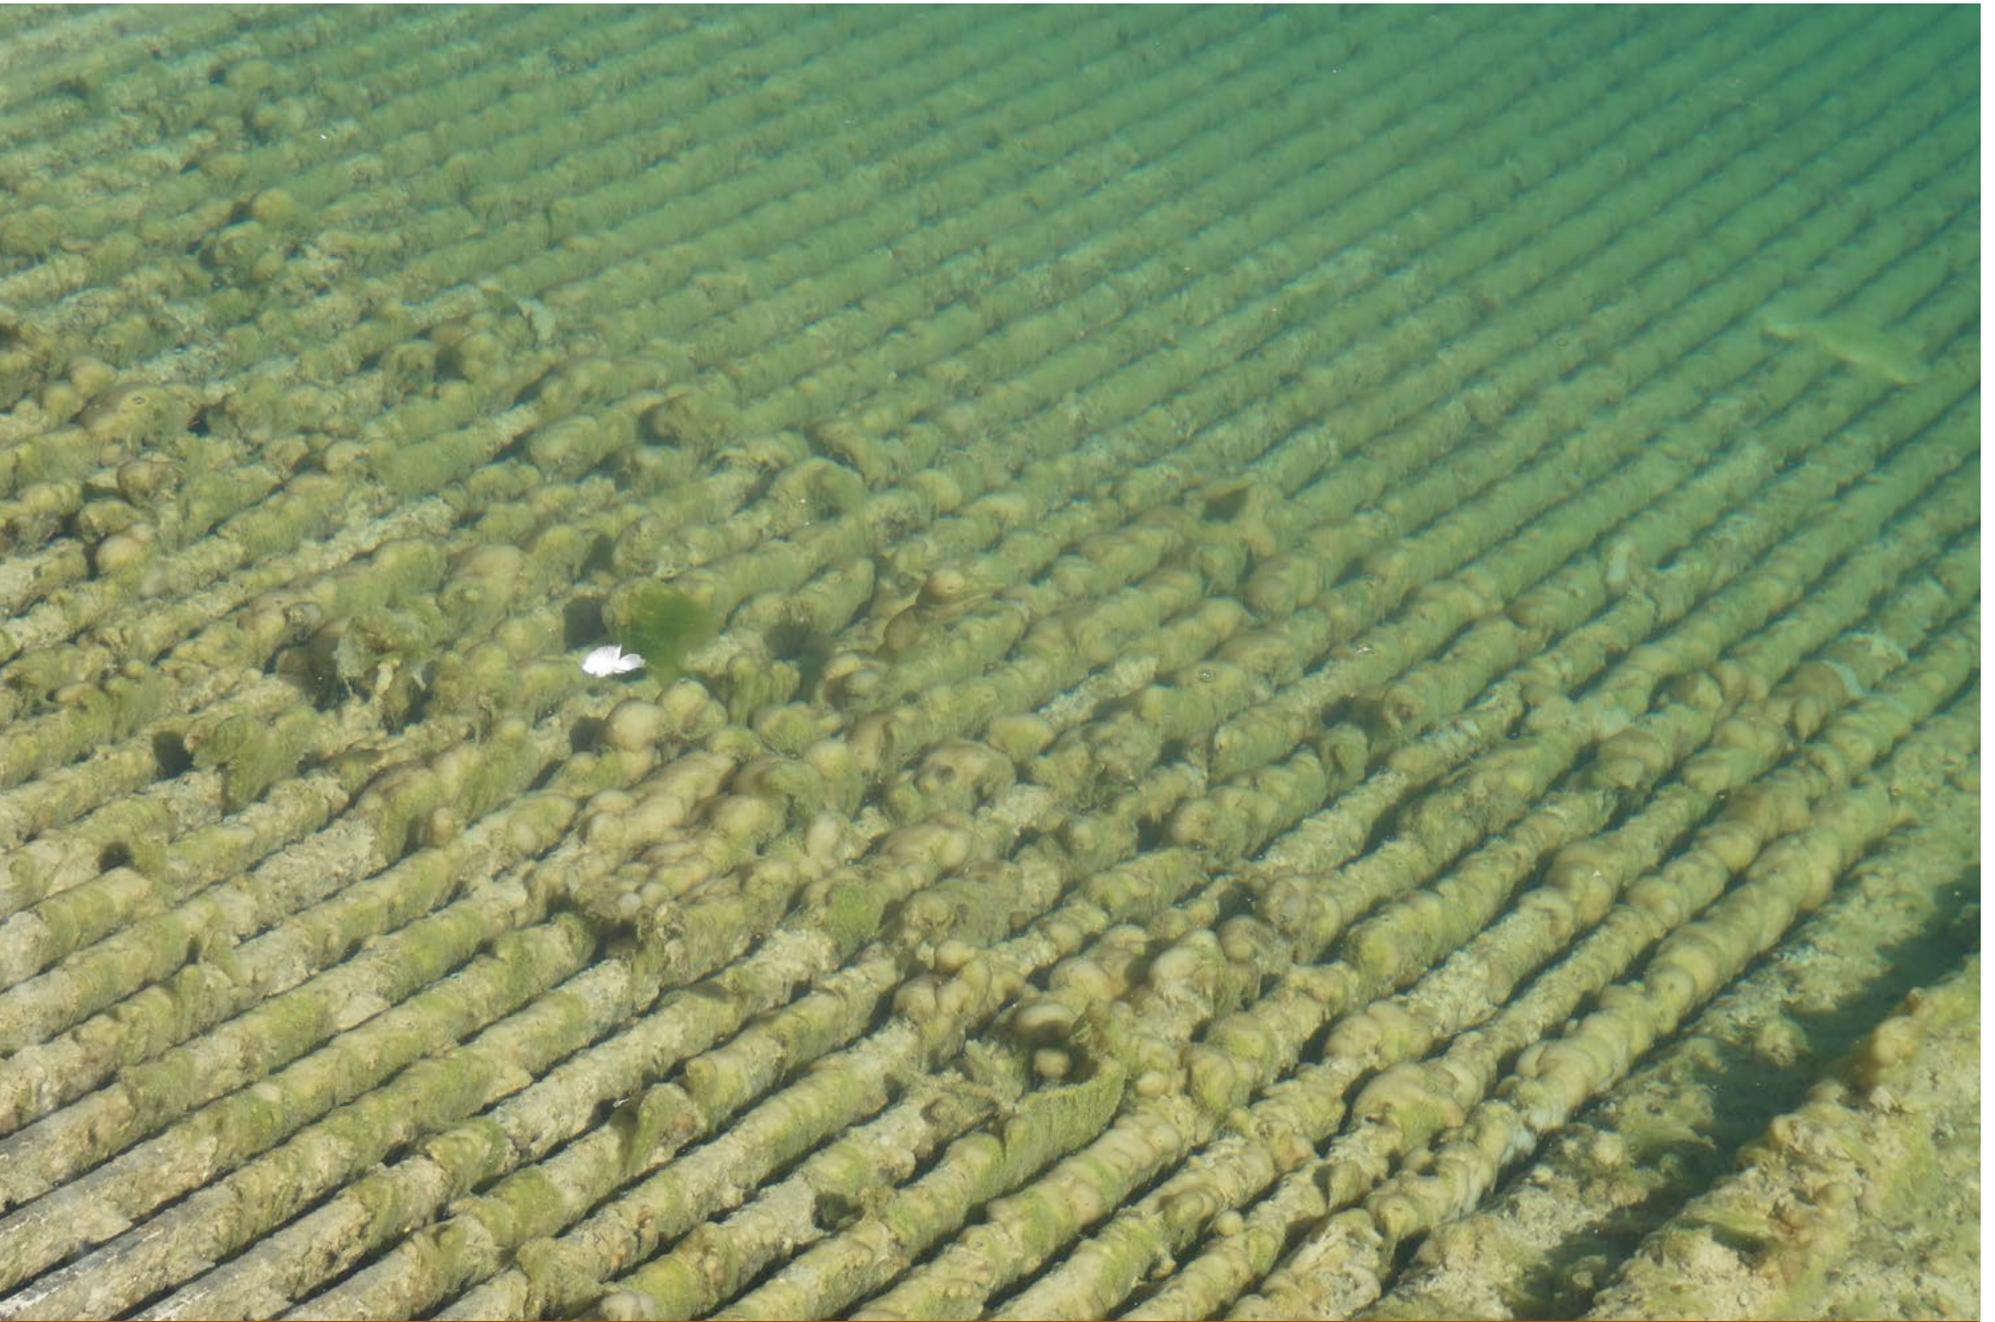
ROCK SNOT GROWTH ON RWCD INTAKE GRATES IN FEBRUARY 2024.

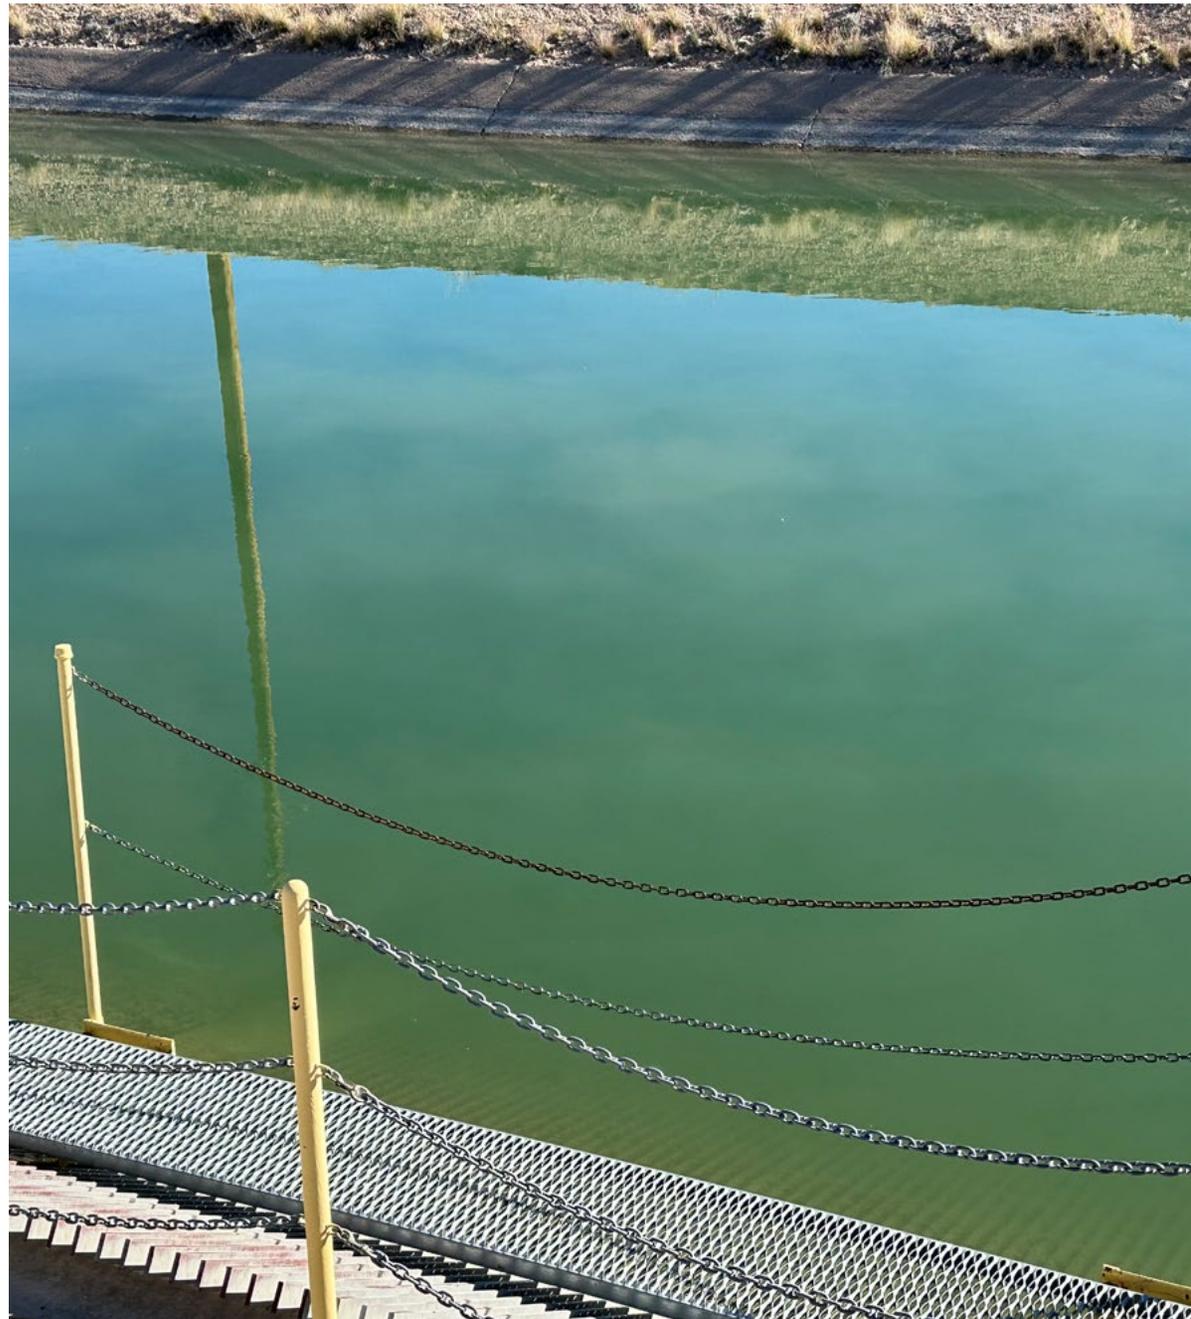
SEDIMENT (TURBIDITY) INCREASES WHEN FLOWS IN WESTERN ARIZONA ARE INCREASED.
