Case Study: Motor Rotor Cracks

LHQ U10 Rotor
2250 HP Electric Motor

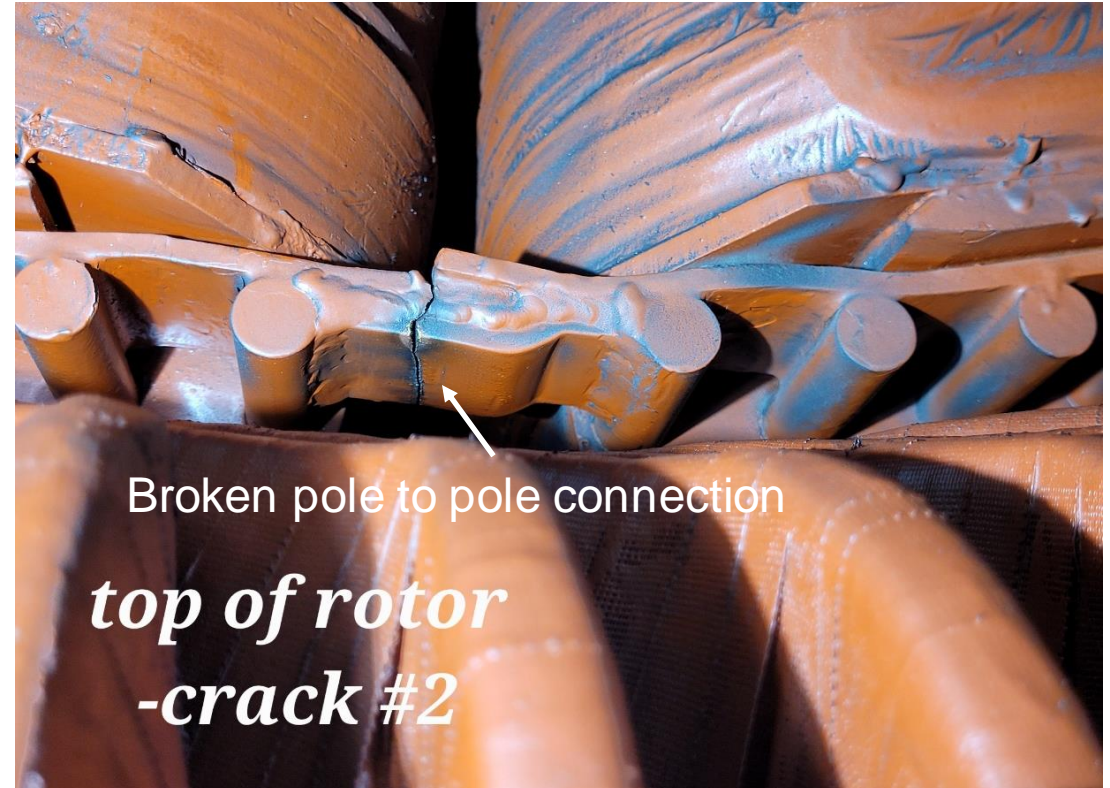
July of 2022, 5 Year Motor PM visual inspection performed

- Six broken rotor pole to pole amortisseur winding connections identified by plant electrician
- CAP Maintenance Organization immediately notified of findings

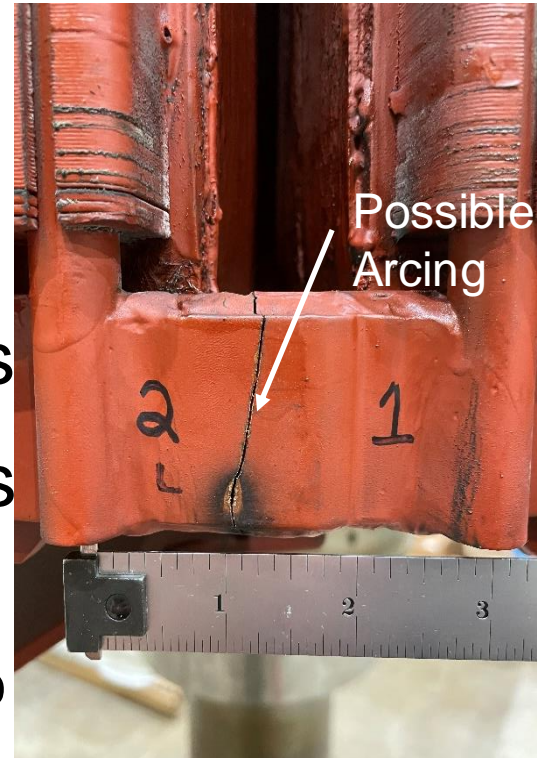
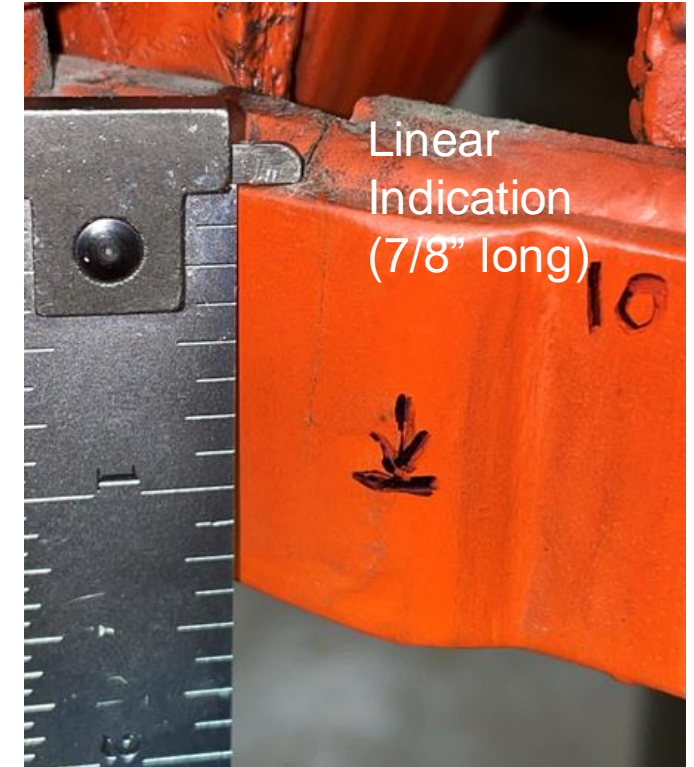
August 2022, rotor removed from unit for further inspection.

- Confirmed six connections with arcing at some locations
- Three additional connections with hairline cracks
 - Lengths vary from $\sim 3/16"$ to $7/8"$

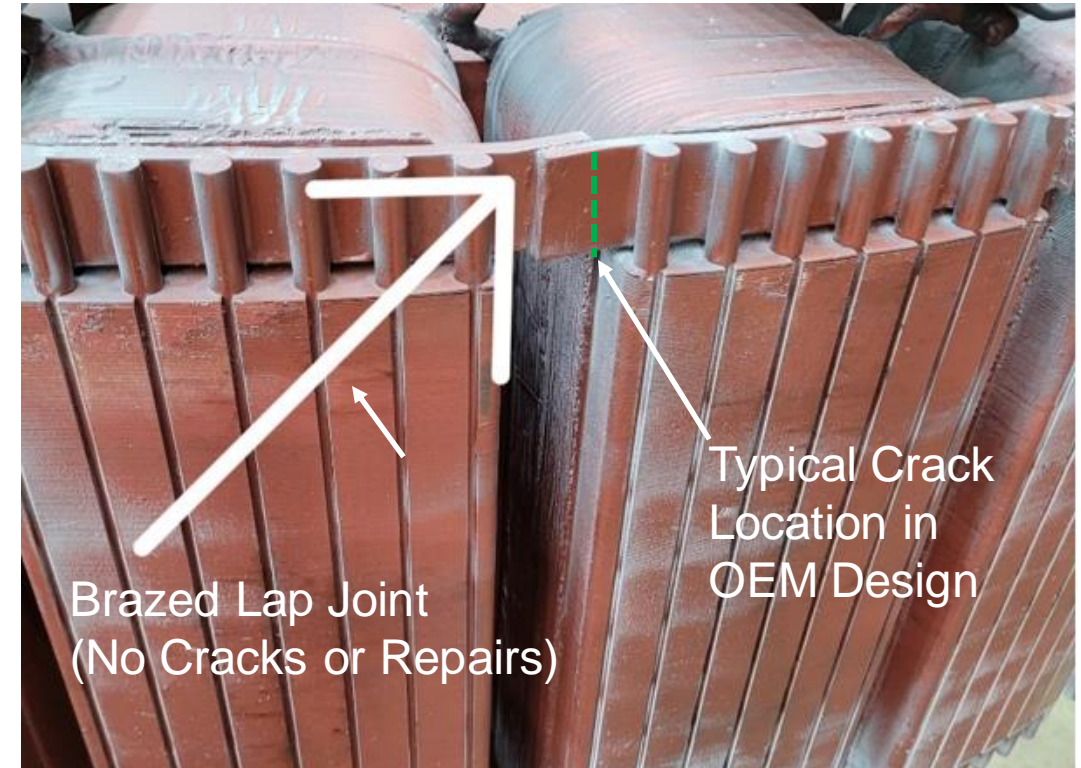
Original Pole to Pole
Amortisseur Connection

Bouse Hills (BSH) and Little Harquahala (LHQ) small unit motors have a history of cracks with the original design.

- Mid-1990s, 6 of 8 small units were identified having cracks
- Hassayampa (HSY) small unit motors had no history of cracks

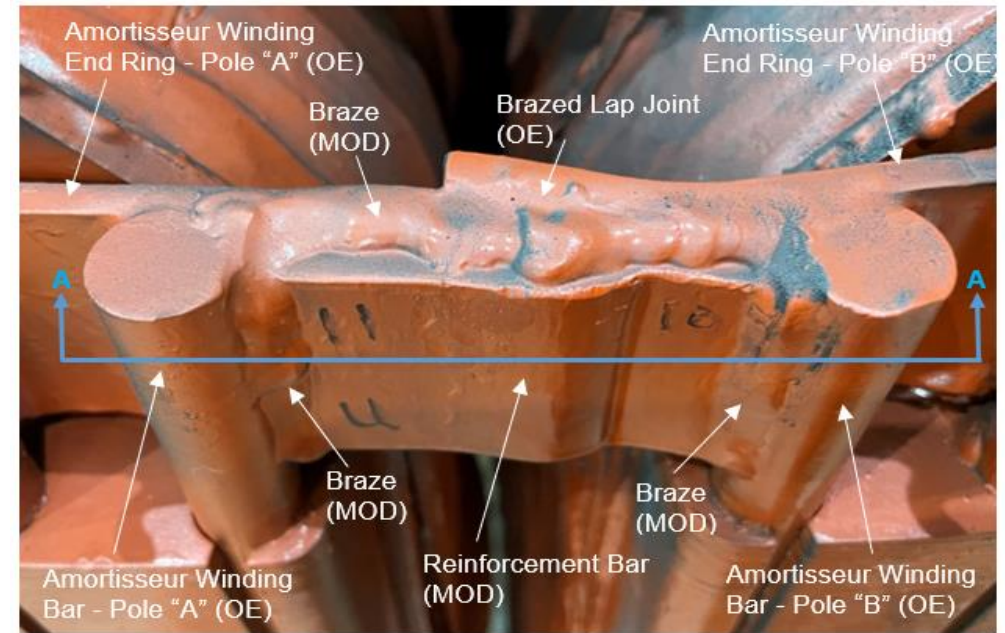
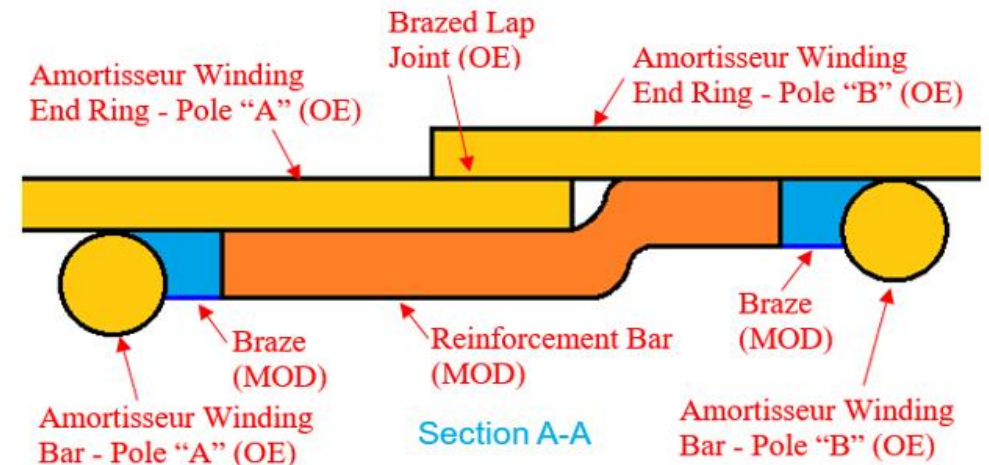
- 1996-2000, all BSH, LHQ, and HSY small units received a design modification.
- Adding reinforcement bar onto lap joint.
 - Brazed in place
- Increased cross section at joint expected to eliminate cracking.

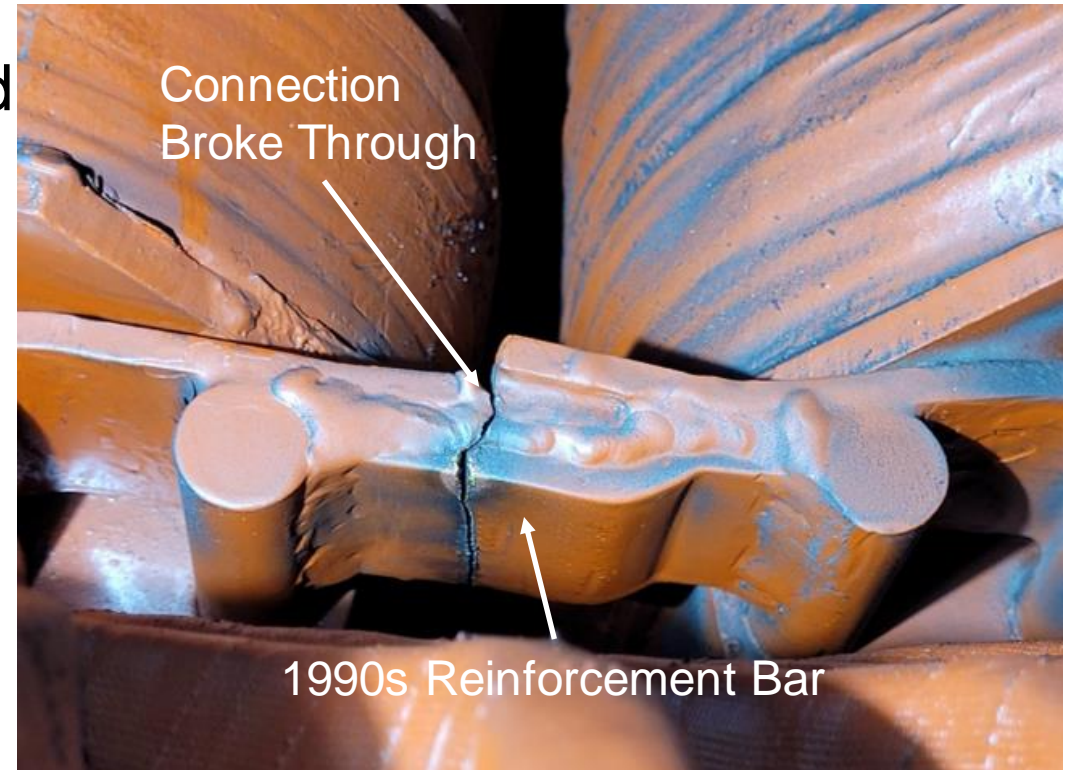
- All six broken connections identified on LHQ U10 had the 1990s modifications performed.
- With these results, all small units of BSH, LHQ, and HSY were inspected.
- Cracks were identified on 6 of 12 units

Modified Pole to Pole Amortisseur Connection With Cracks [LHQ U10 – July 21, 2022]

- Insufficient OEM Design
 - Connection not sufficient for operating stresses
 - thermal expansion of rotor during operation (20 °C to 60°C)
 - Inertial forces
- Modifications in 1990s not adequate
 - May have introduced residual stresses (counterproductive)
