2021 BIOLOGY ANNUAL REPORT

Central Arizona Water Conservation District Water Transmission Division

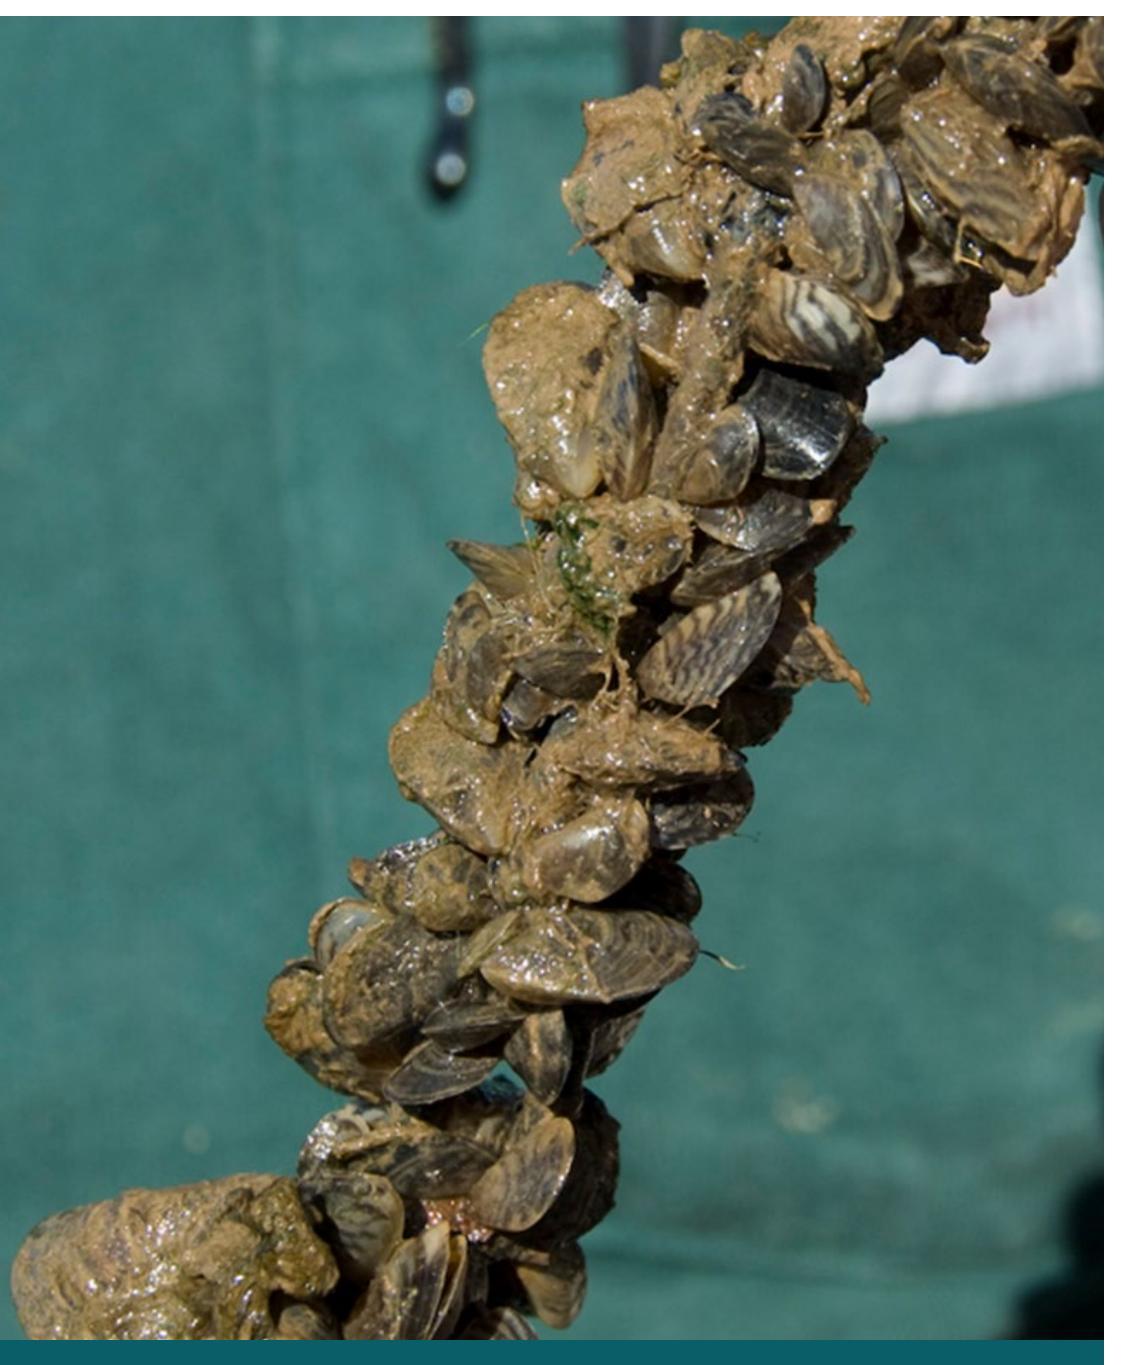
QUAGGA MUSSELS ATTACH TO A ROPE AT MWP

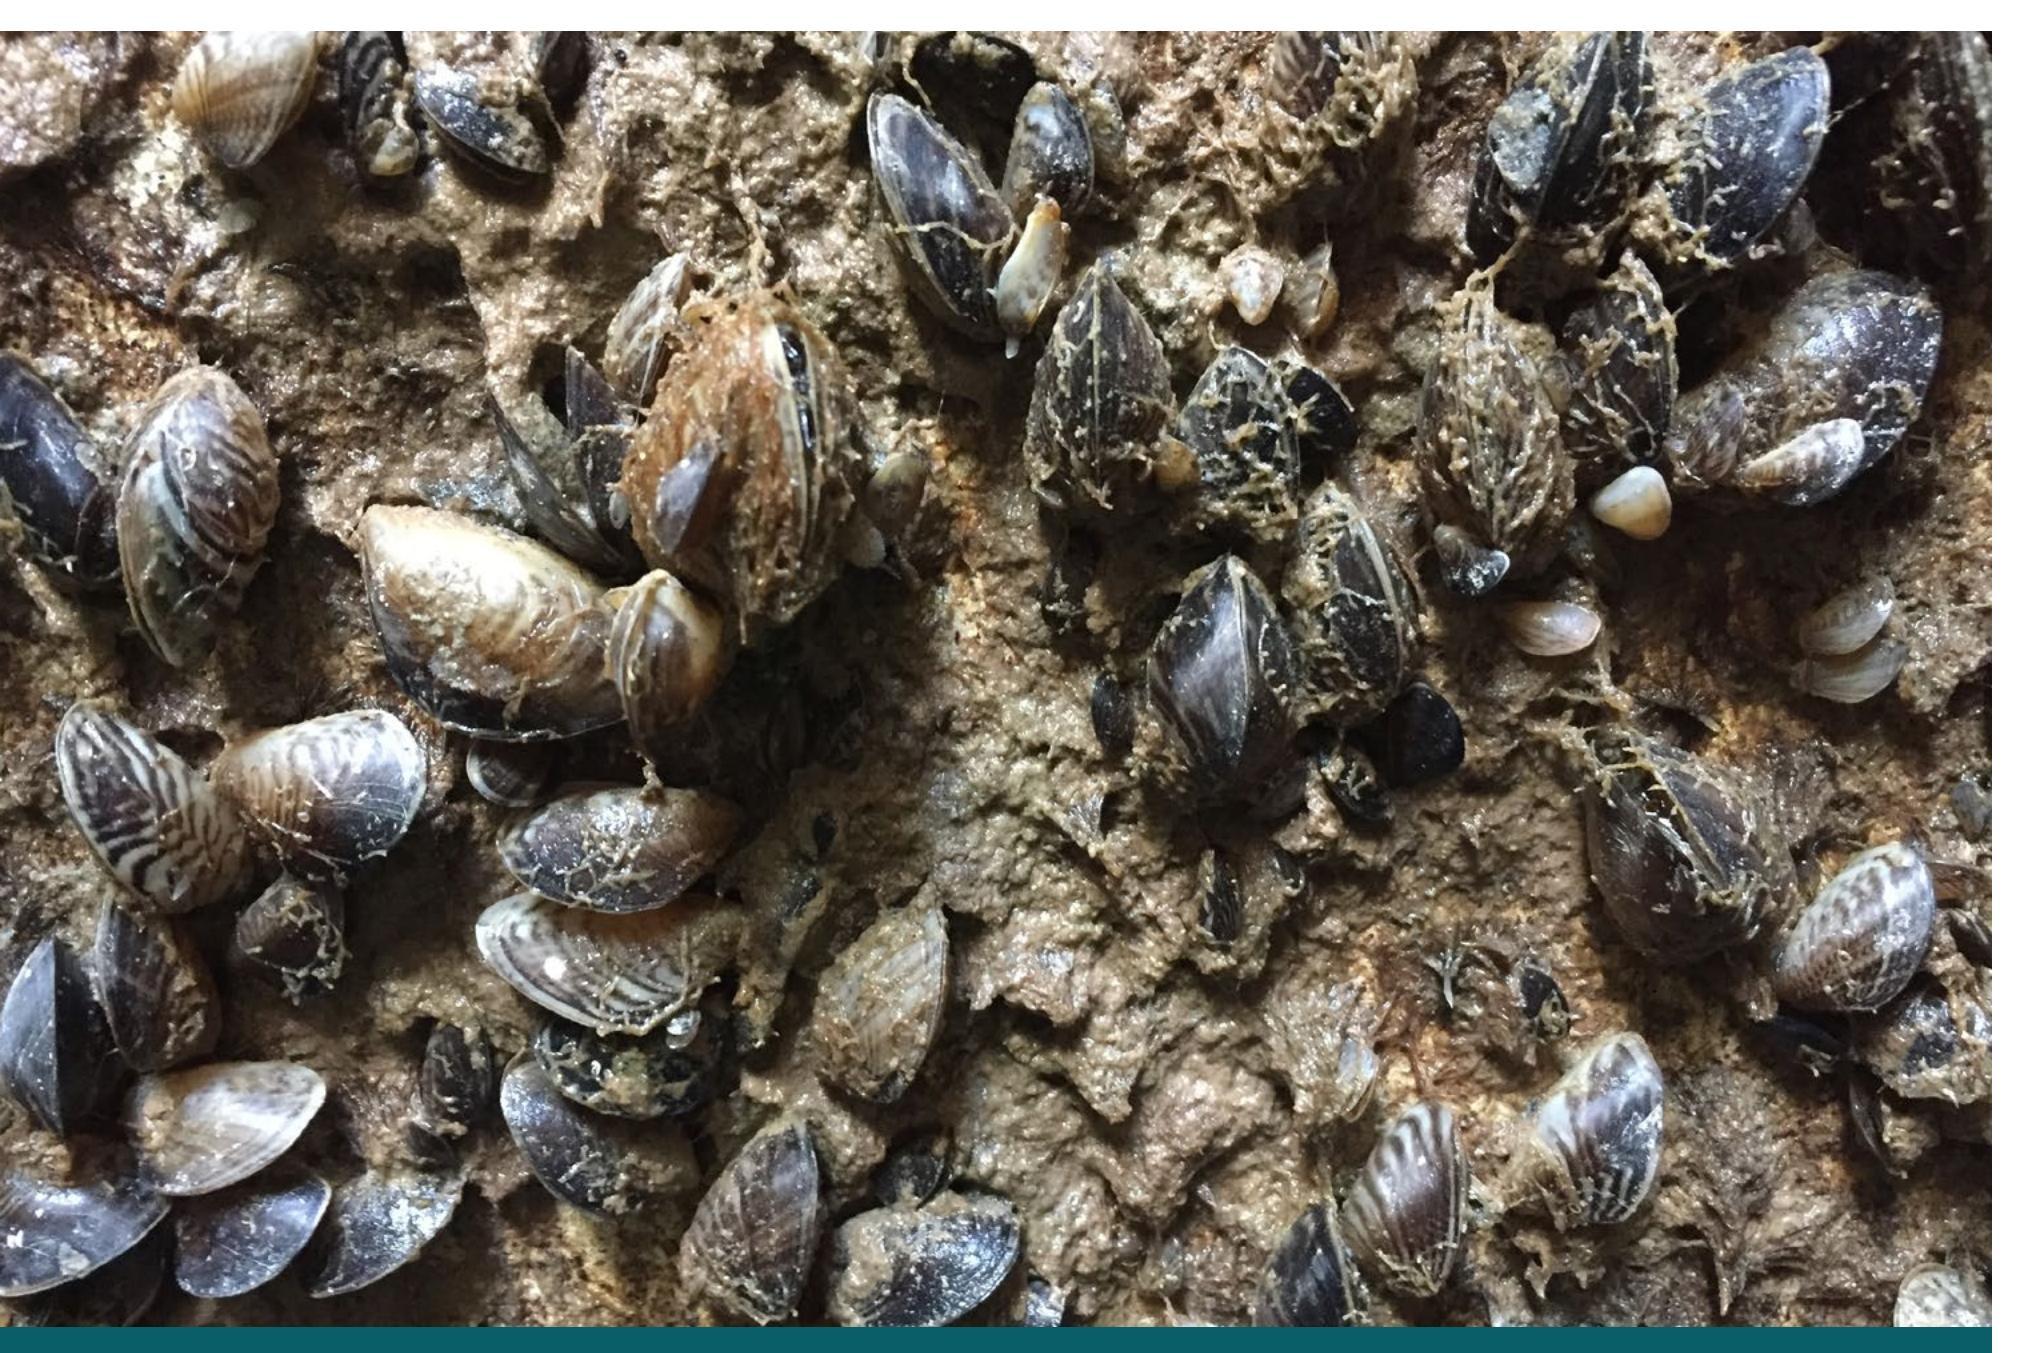
QUAGGA MUSSELS IN GLENDALE TURNOUT Photo by Jim Geisbush

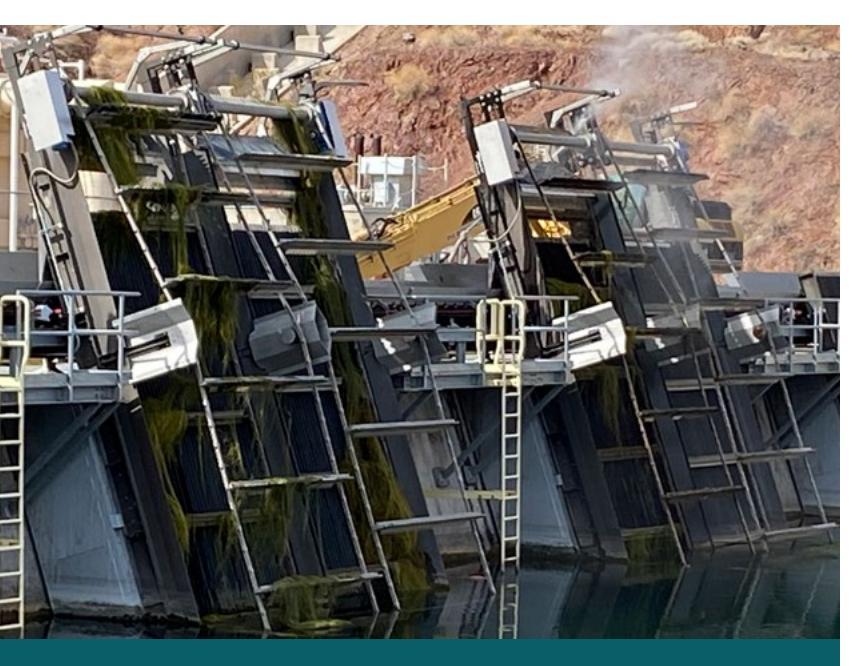
TRASH RAKES AT MWP COLLECT AQUATIC WEEDS, BUT DUE TO THE COMPOSITION OF THE WEEDS, THE RAKE SYSTEM HAS BEEN INEFFECTIVE.

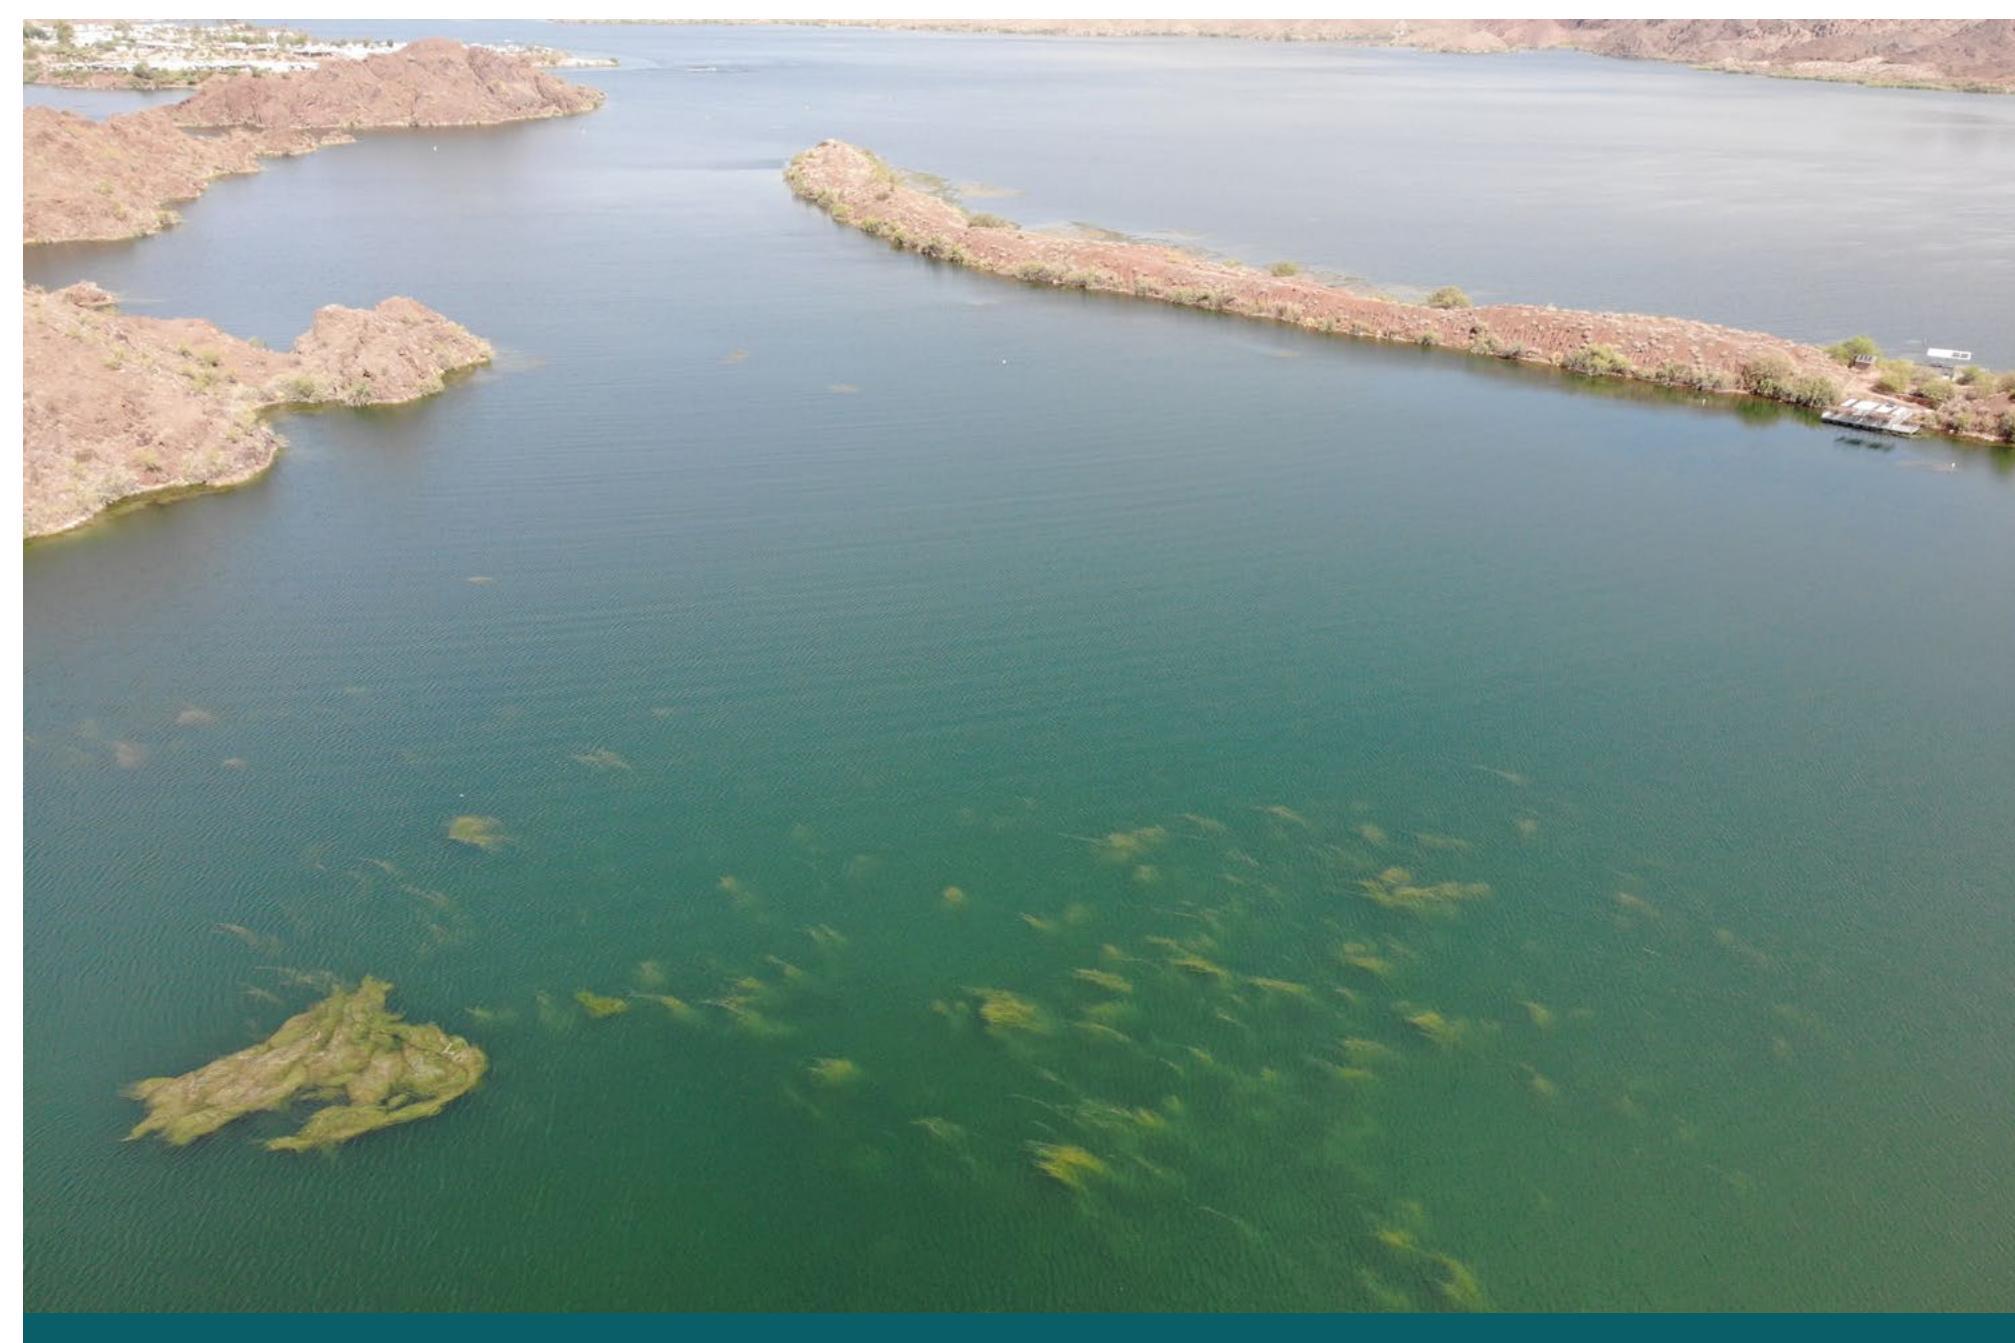
Mapping of vegetation within the intake channel showed that vegetation growth was heavier and more widespread than in previous years.

AQUATIC VEGETATION GROWTH IN THE CAP INTAKE CHANNEL IN AUGUST 2021. *Photo by Michael Rogers*

In 2022, CAP will focus the weed treatment on the shallow areas where pondweed is most prevalent. This will help to control the large weed mats that form in mid-July, while the naiad mats that form later in the summer will be collected with the weed harvesting boat. Vegetation coverage and plant height will be mapped bi-weekly to evaluate the effectiveness of the treatments and monitor overall vegetation growth. CAP's weather station will be downloaded monthly to correlate weather/wind events with the movement of vegetation mats.

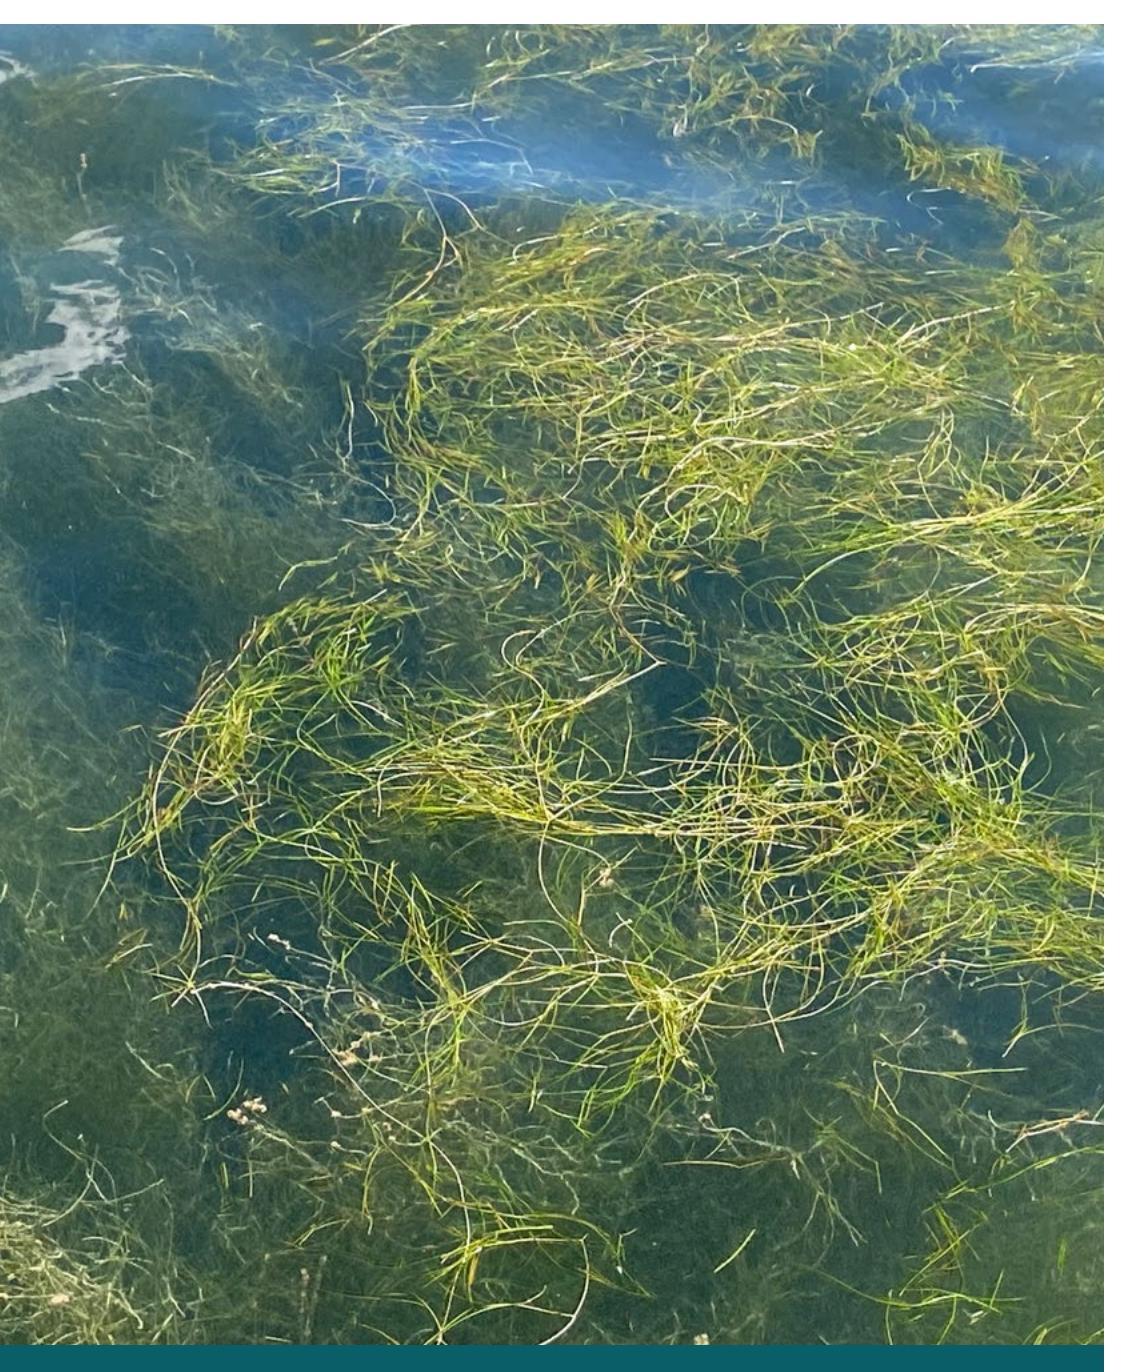
VEGETATION GROWTH IN THE WAD FOREBAY DURING APRIL 2021.

An "island" of rooted vegetation was found growing in WAD forebay during spring and early summer. The vegetation was growing on a large mound of sediment that periodically forms in the forebay. Typically grass carp will control this vegetation, and an increase in stocking rates may be required in 2022 to ensure that it doesn't grow out of control. Filamentous algae was once again evident throughout Waddell Canal during summer months, but was somewhat lighter growth than observed in previous years. CAP maintenance crews scraped municipal turnouts on just a few occasions, but no problems were reported. The Arizona Center for Algae Technology and Innovation (AzCATI) at Arizona State University (ASU) is currently studying algae and Cymbella issues in the CAP System. They have deployed sensors that detect biological growth throughout the canal system, and as they refine processes, will be able to provide CAP and its stakeholders with indicators of the potential for algal blooms. The study will conclude at the end of 2023.

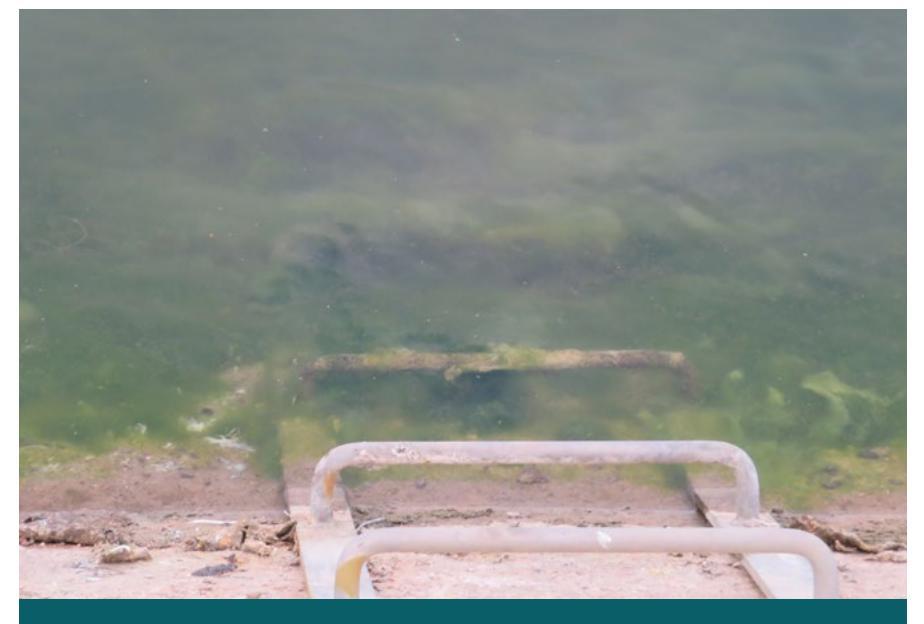
FILAMENTOUS ALGAE OFTEN GROWS IN THE WADDELL CANAL IN MID-SUMMER.

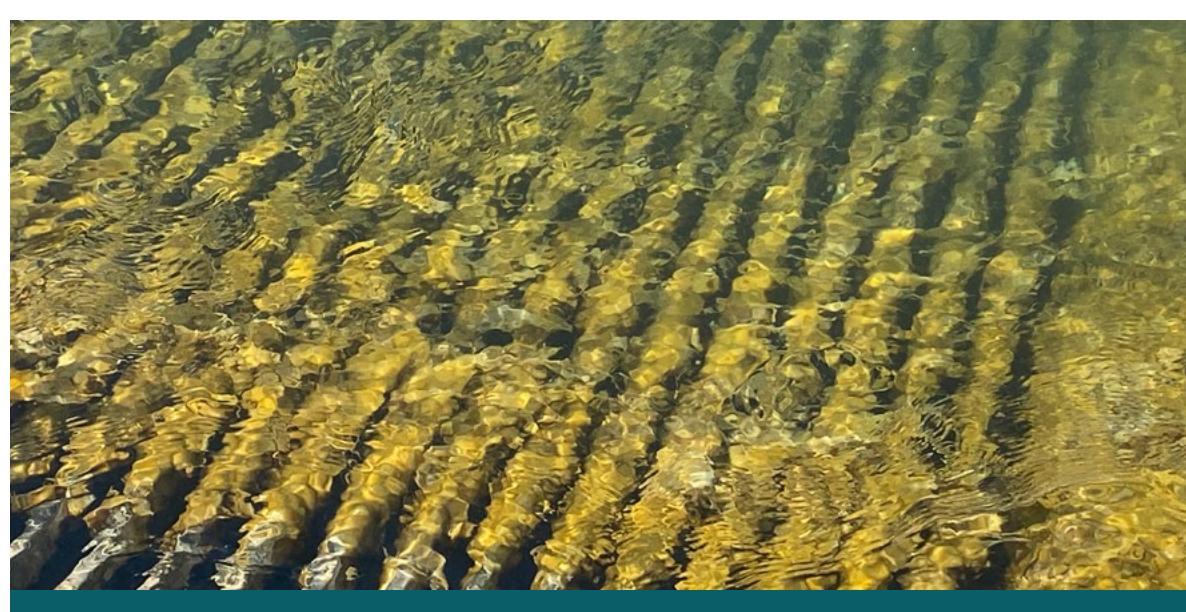
CYMBELLA THAT HAS DETACHED FROM THE CANAL LINER GETS CAUGHT IN TURNOUT GRATES AND CAN RESTRICT FLOW TO WATER TREATMENT FACILITIES.

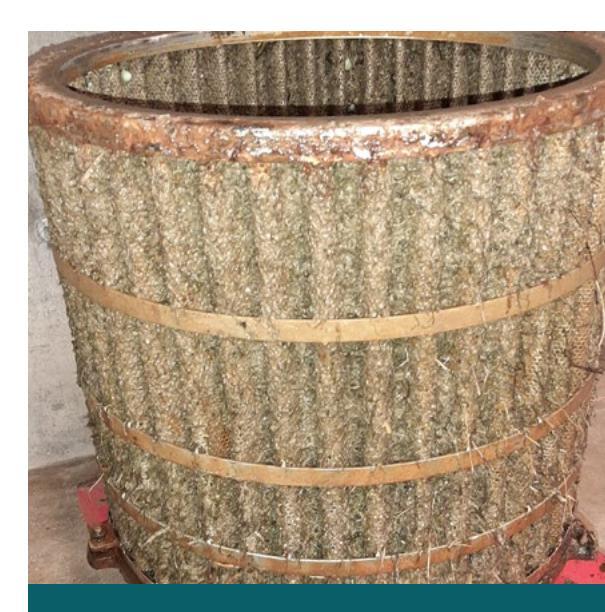
CYMBELLA DEBRIS CAN CLOG FILTRATION SYS-TEMS AND STRAINERS IN PUMPING PLANTS.

The AzCATI research also identified a chemical solution that may be used to help breakdown the organic material when it clogs filters and strainers. Use of the chemical may be used when backwashing or power washing the strainers to speed the cleaning process.

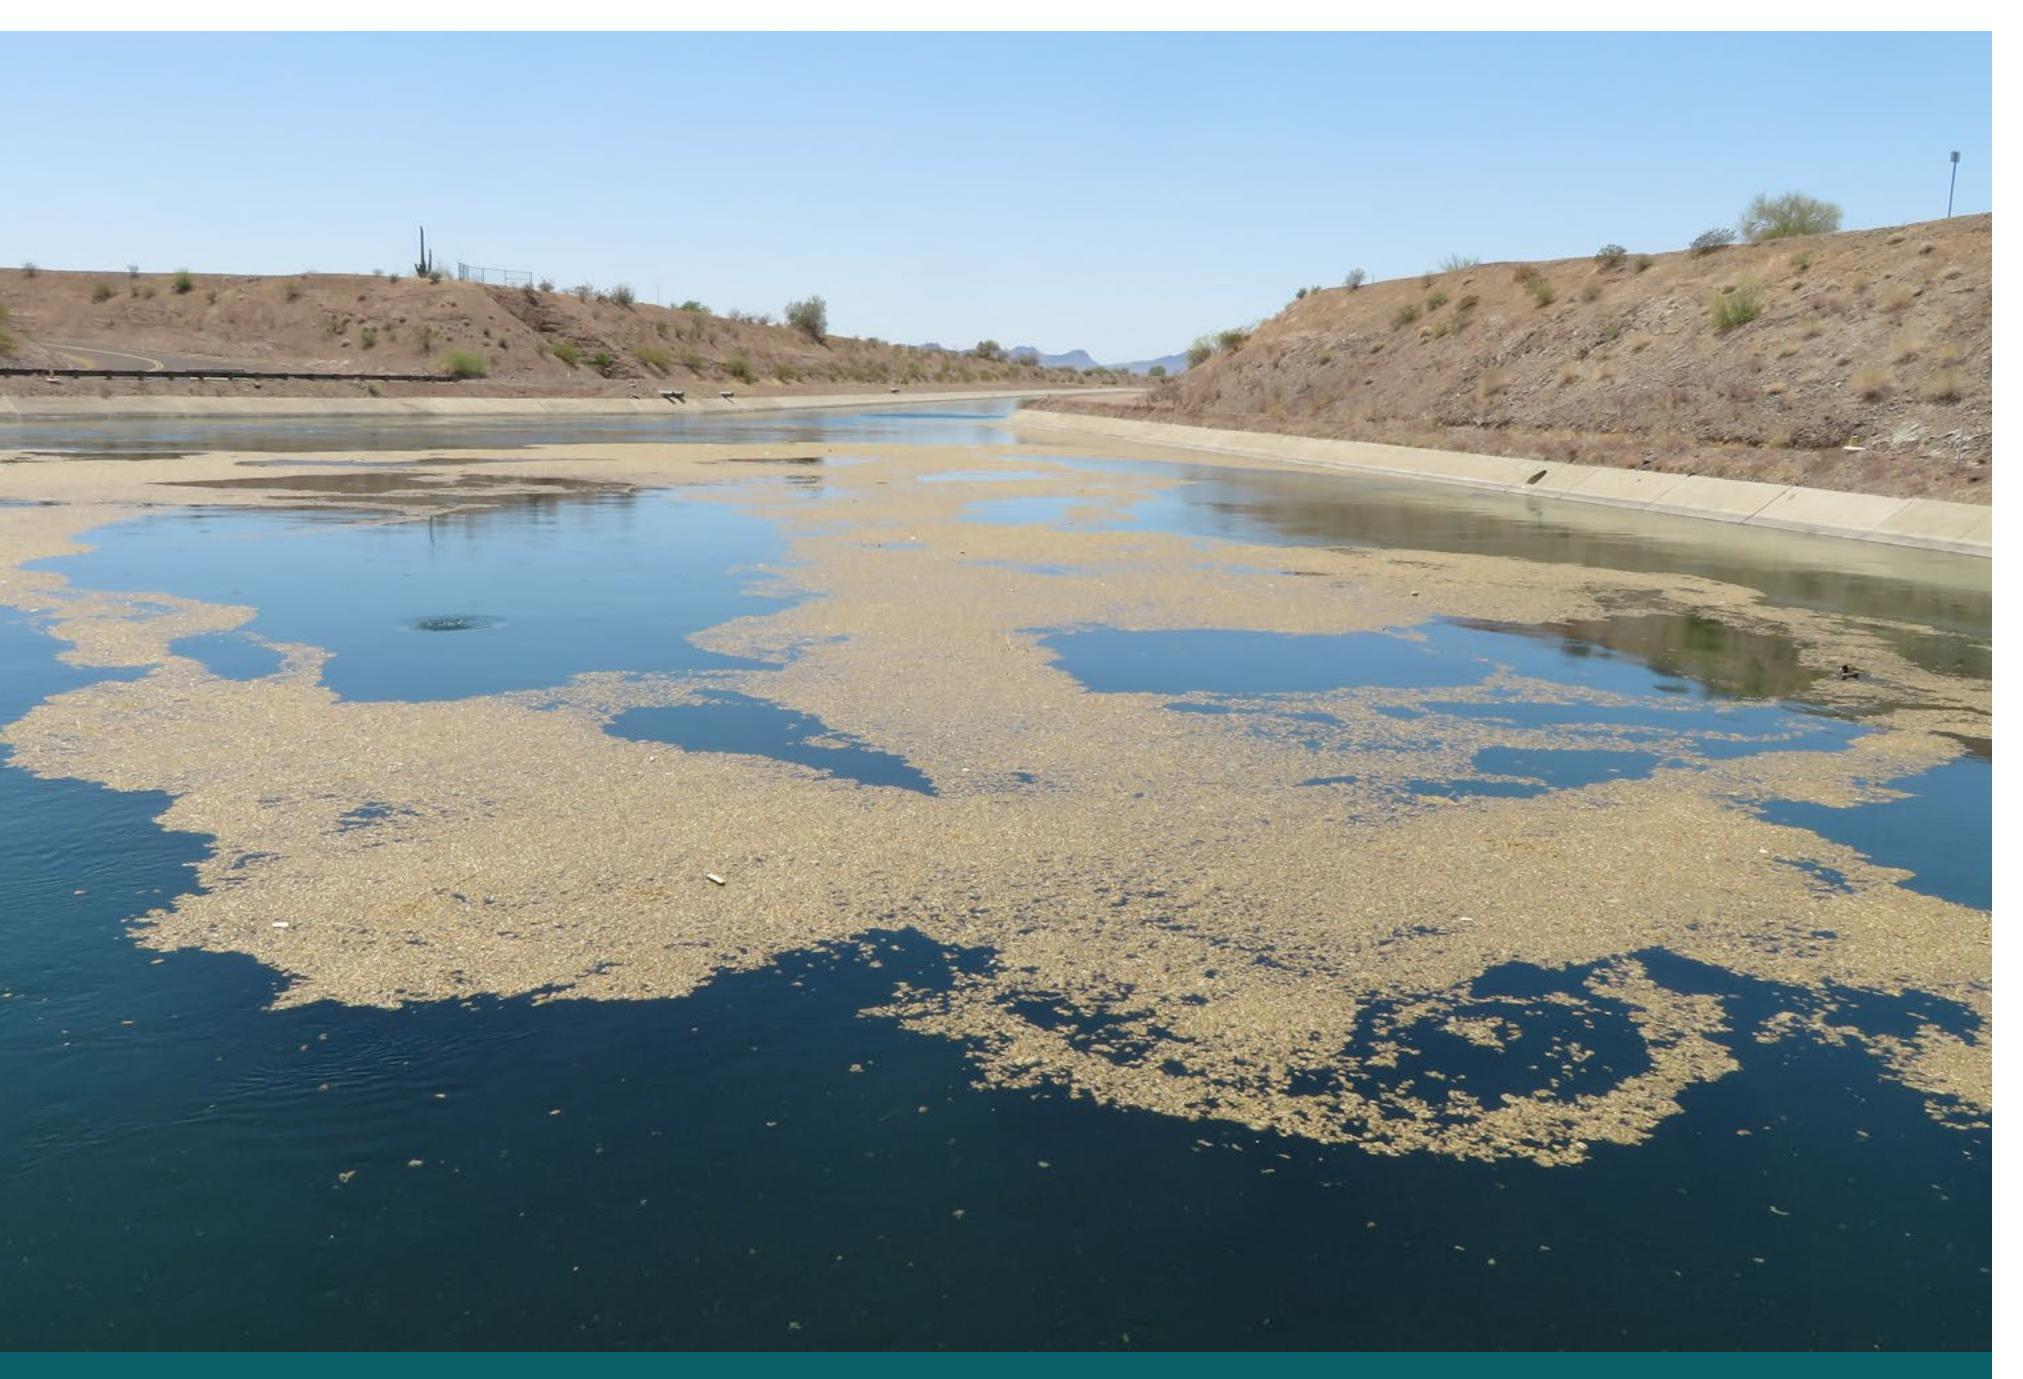
Within the canal, a significant amount of floating material broke off from the canal liner in the western portion of the CAP. Crews at LHQ observed a large amount of material on the surface of the forebay in March, and cooling water strainers were constantly plugged with the organic material. This "event" impacted the pumping plant through the end of June and only subsided with the summer outage. The Senior Biologist traced the problematic Cymbella and found that the bloom originated in Pool Bouse. As the material moved through the pumps at LHQ, it was broken into smaller pieces and was distributed throughout the water column. Material was observed as far south as BRD, approximately 250 miles downstream. Despite the widespread distribution, impacts to stakeholders and downstream pumping plants were minimal, although Apache Junction reported some pump issues. The reason for the significant bloom is unknown.

A CYMBELLA BLOOM IN EARLY 2021 CREATED A LARGE AMOUNT OF FLOATING DEBRIS IN THE CAP SYSTEM THROUGHOUT MUCH OF THE SPRING AND SUMMER.

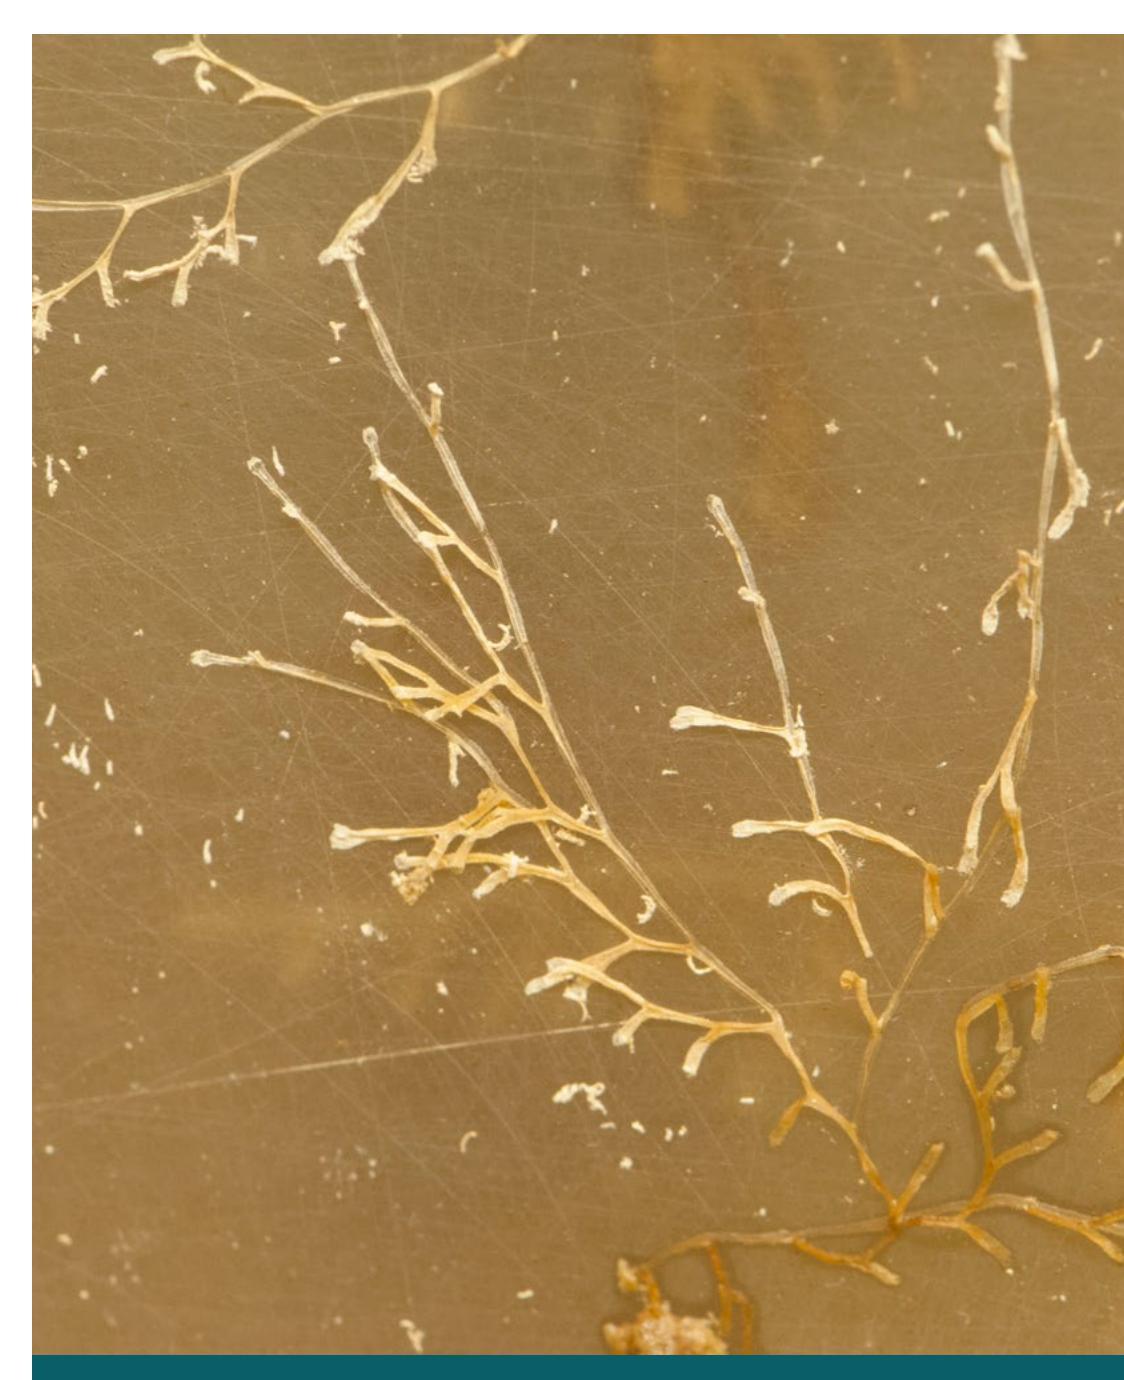
COLONIAL HYDROIDS GROWING IN A BIO-BOX AT MWP

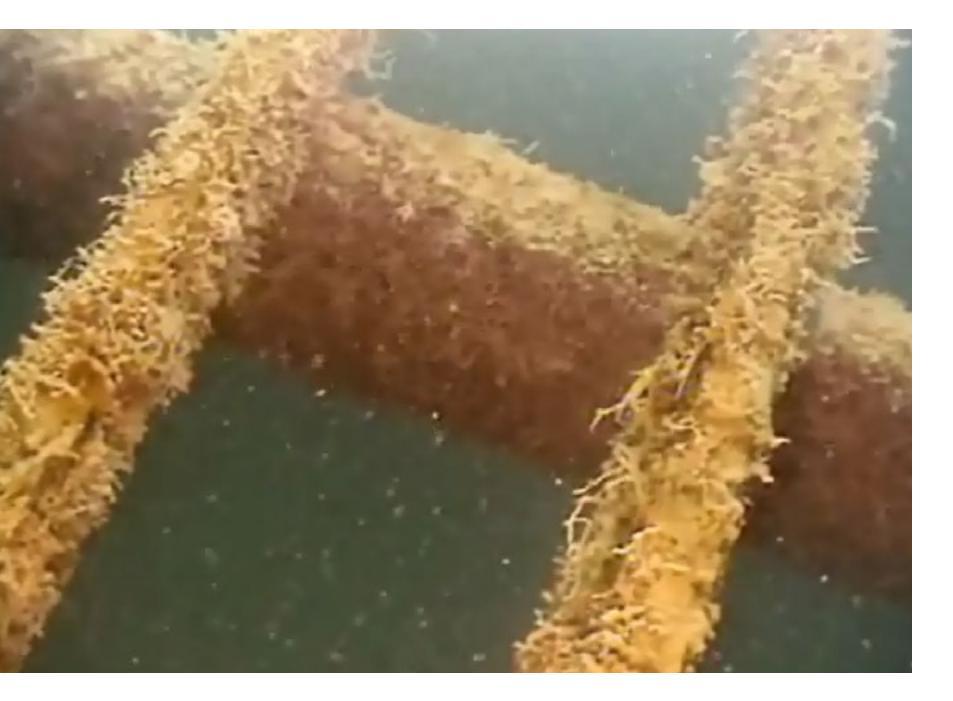
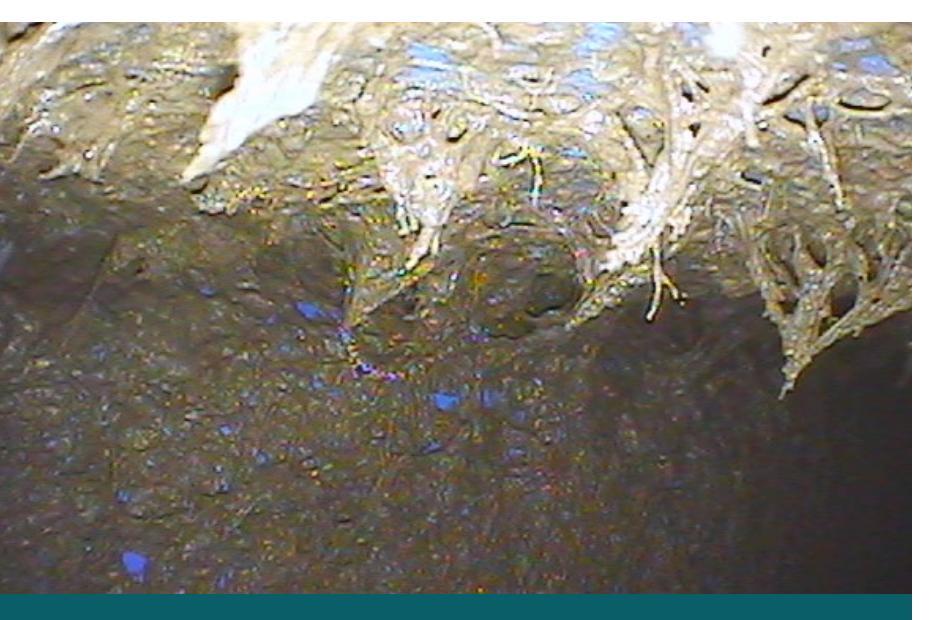
HYDROIDS CAUSE BIOFOULING ON TRASH RACKS AND IN COOLING WATER SYSTEMS.

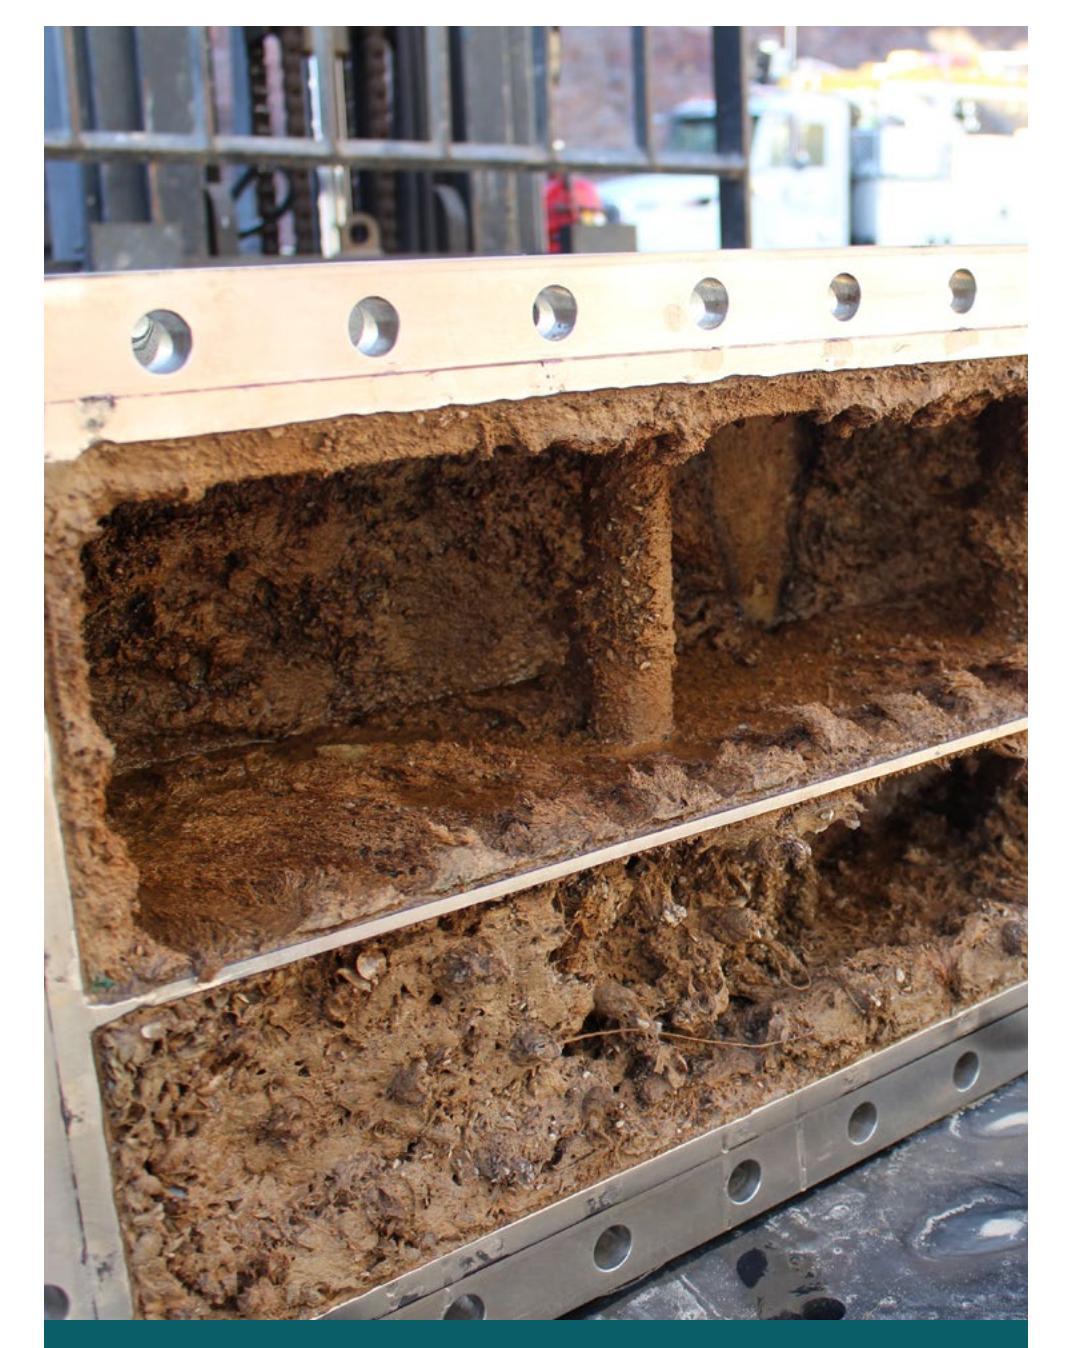
HYDROIDS INCREASE SURFACE AREA FOR ATTACHMENT OF QUAGGA MUSSELS AND TOGETHER, CAN REDUCE THE FLOW OF COOLING WATER.

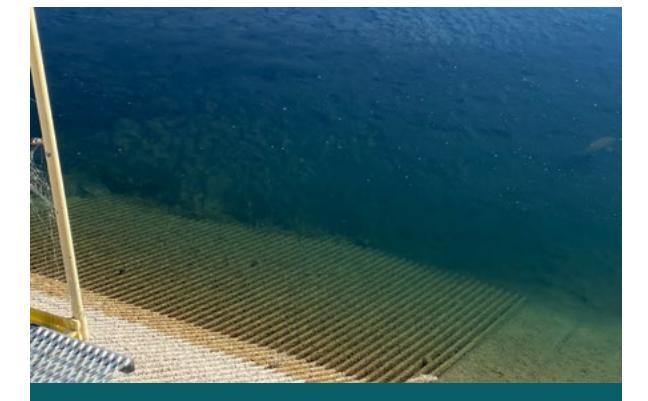
SEDIMENT CAN BUILD UP AT MAJOR TURNOUTS AND RESTRICT WATER FLOW.

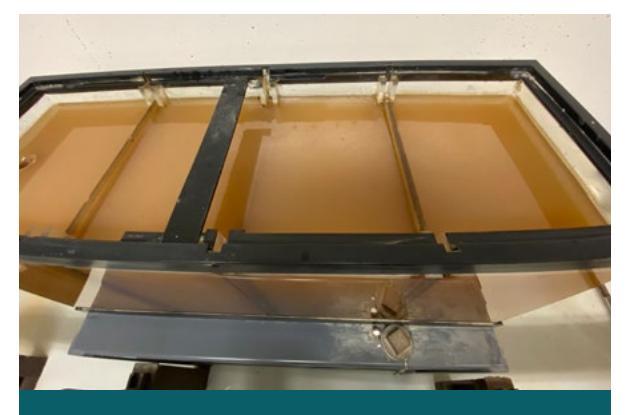
No dredging occurred in 2021; however, a storm event in late summer just upstream of RED (Pool 34) deposited a large amount of sediment in the canal and downstream turnouts. A temporary repair has been completed, with broken concrete panels being replaced by a compacted earthen liner. Erosion is expected to be minimal and future mapping will show how much sediment has entered the system with this event and subsequent repair.

SEDIMENT FROM THE POOL 34 LINING FAILURE WAS VISIBLE IN THE BIO-BOX AT BRW.

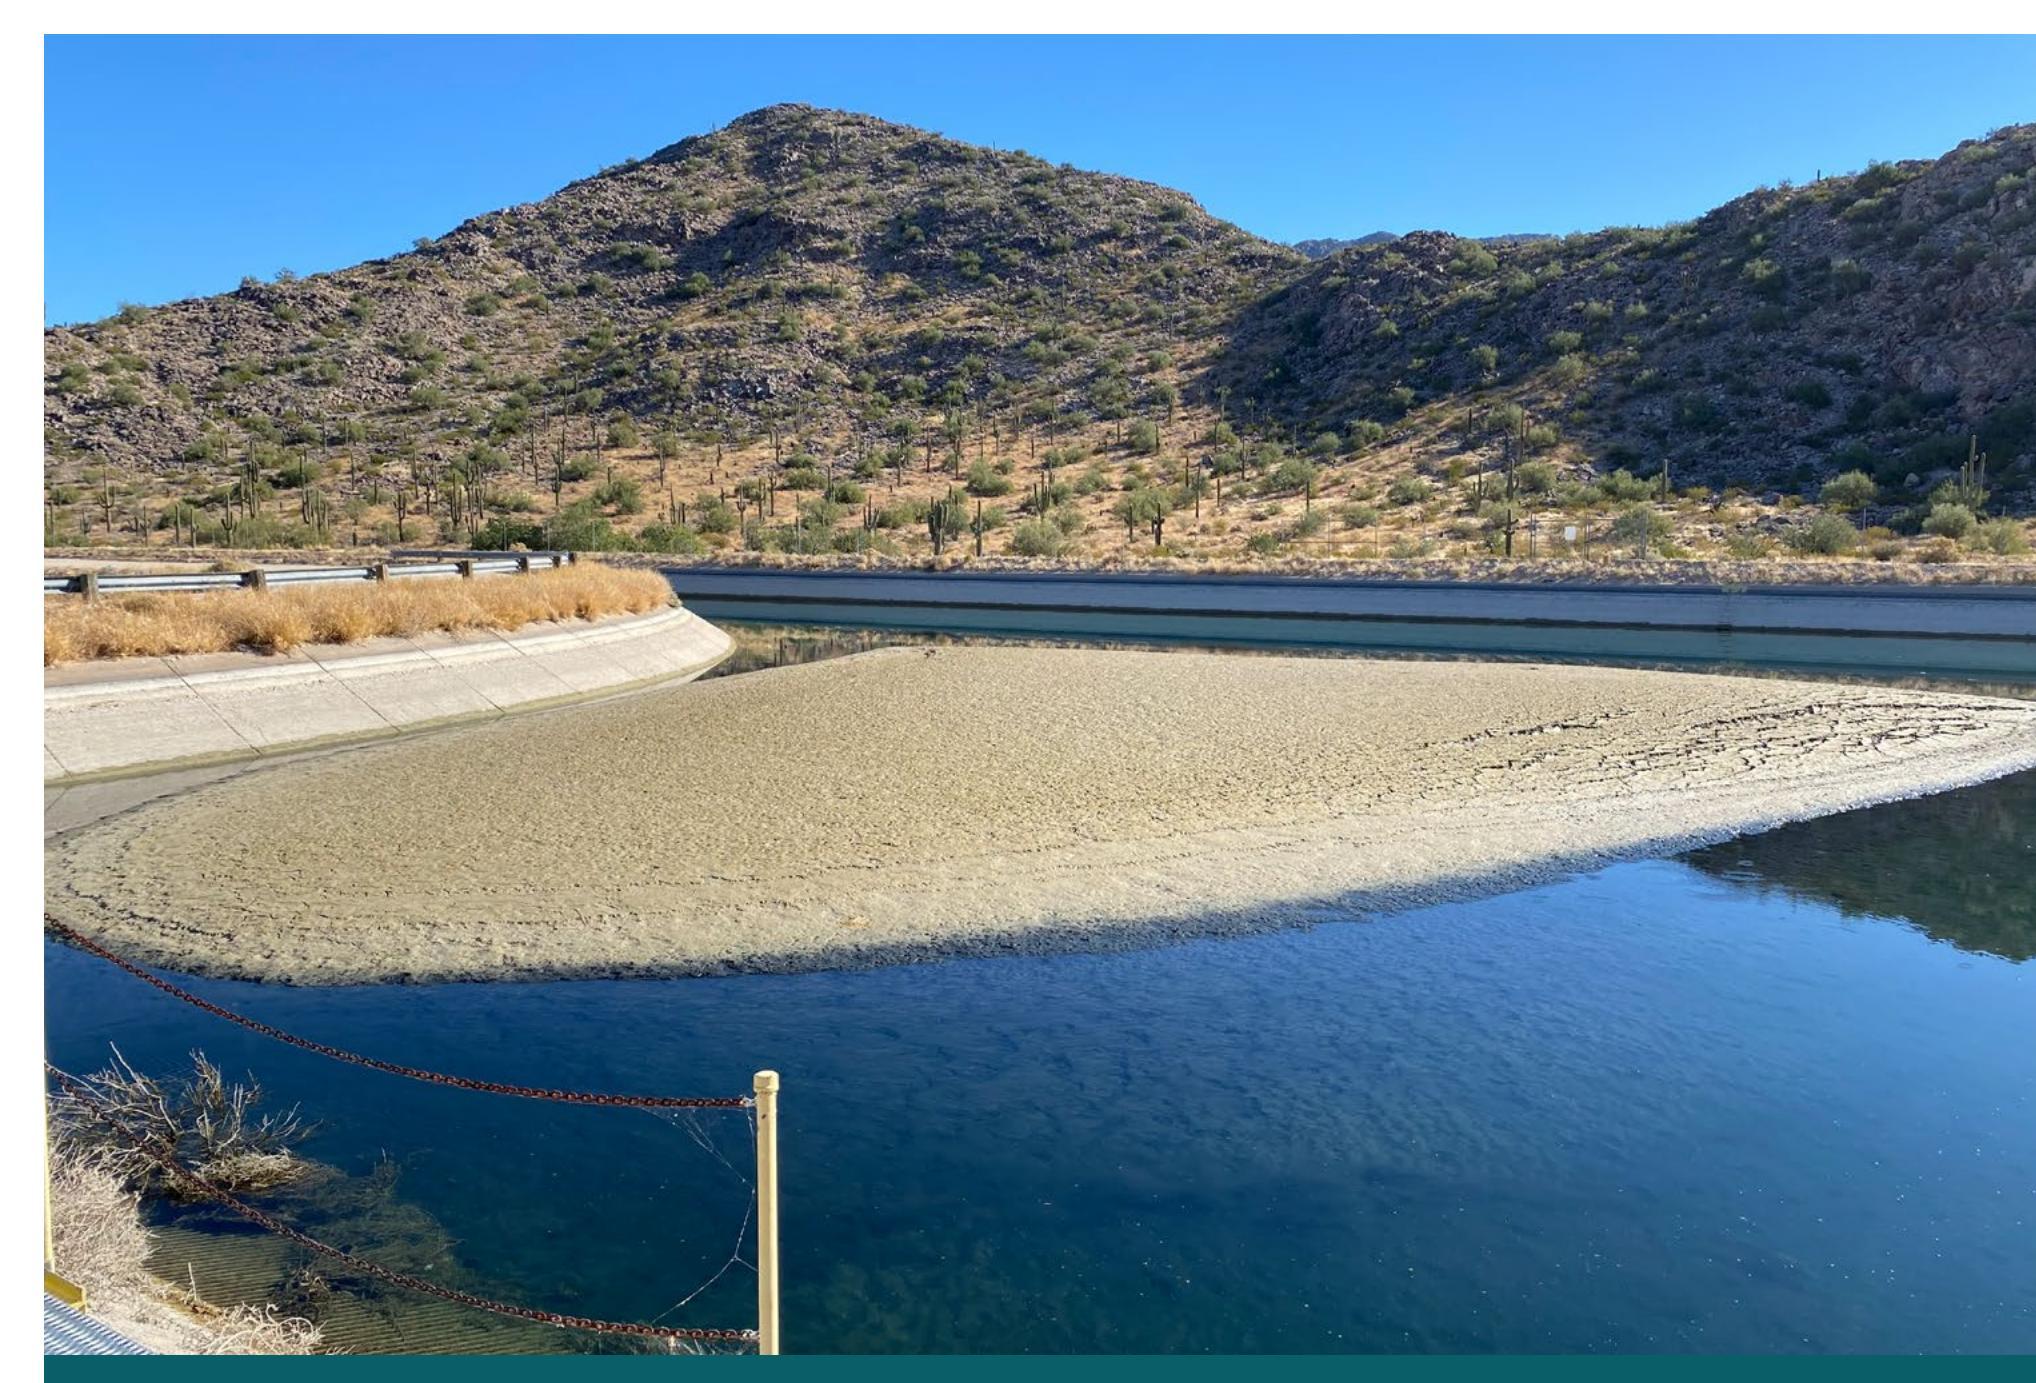
WHEN WATER LEVELS ARE DOWN, A LARGE MOUND OF SEDIMENT IS VISIBLE AT CENTRAL MAIN TURNOUT.
