2020 BOLOGY ANNUAL REPORT

Central Arizona Water Conservation District Water Transmission

CAP BIOLOGY PROGRAM

by Scott Bryan, Senior Biologist

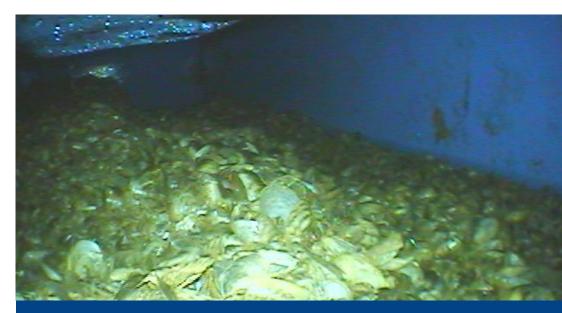
With no treatment at MWP, quagga mussels and colonial hydroids continued to persist in the cooling water systems and caused at least two unforced outages due to overheating. The installation of the chemical injection system is expected to help prevent future settlement of invasives in this critical system.

A videoscope photo of quagga mussel settlement in the cooling water header boxes at MWP. This level of infestion clogs the cooling tubes and prevents the motor from being properly cooled, eventually causing the motor to trip due to overheating.

A chemical injection system has been installed on each of the six unit cooling water systems at MWP to help prevent biofouling and subsequent overheating of the motors.

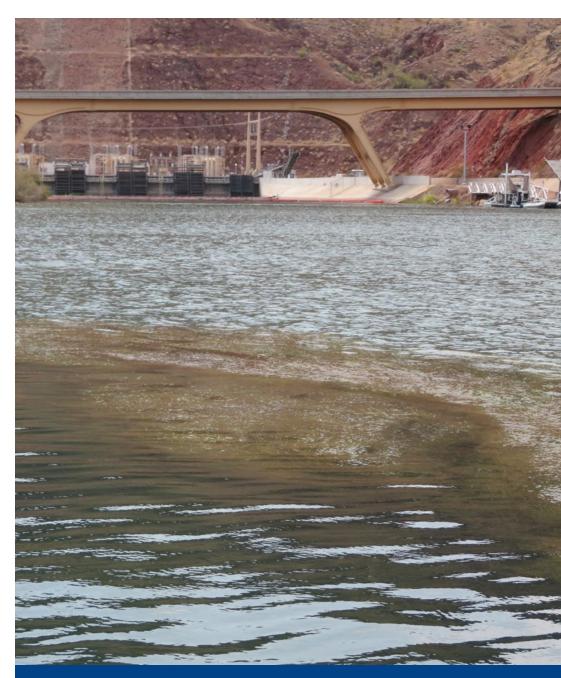
FLOATING WEED MATS APPROACH MWP DURING SUMMER MONTHS Photo by Scott Bryan

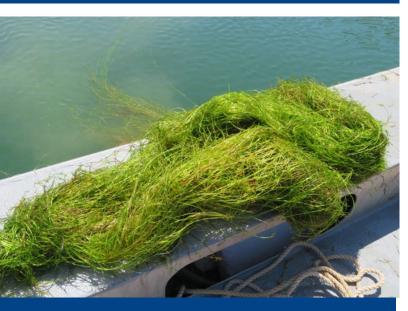
The vegetation treatment had little impact on weed growth in 2020 at the Salt River Siphon

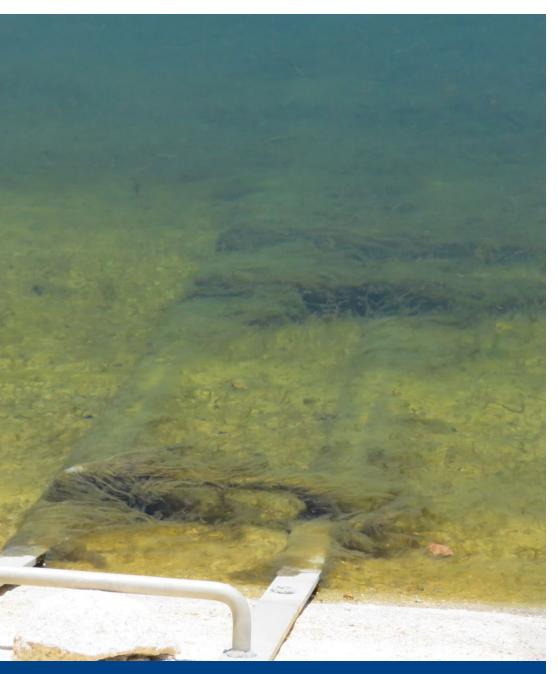
ALGAE GROWTH IN WADDELL CANAL IN JUNE 2020 Photo by Scott Bryan

Relatively heavy algae growth was observed from June through September 2020 in the Waddell Canal and throughout the canal in the Phoenix metropolitan area. In late July, the City of Glendale reported that algae was restricting water flow at their turnout, then Phoenix reported similar findings in early August, and Mesa and Chandler experienced troubles in mid-August. The algae, which was primarily growing in Waddell Canal, was detaching from the canal liner and floating downstream, eventually clogging the trash racks at these turnouts. CAP maintenance crews manually scraped the debris from the racks several times each week (and more often when needed) through mid-September. The factors contributing to the heavy algae growth in Waddell Canal during the summer months are only speculative at this time, and may be related to nutrient release from Lake Pleasant. The Arizona Center for Algae Technology and Innovation (AzCATI) at Arizona State University (ASU) is currently studying algae and Cymbella issues in the CAP System and may provide insight into the conditions that contribute to the algae growth and potential solutions at the conclusion of their study (in 2022).

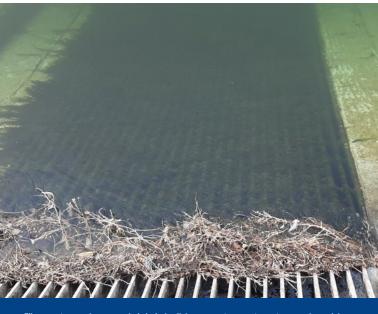
Filamentous algae and debris builds up on turnout grates and could potentially restrict flow.

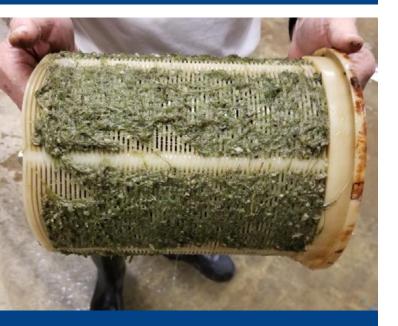
Algae fouling on a filter at LHQ in August 2020.

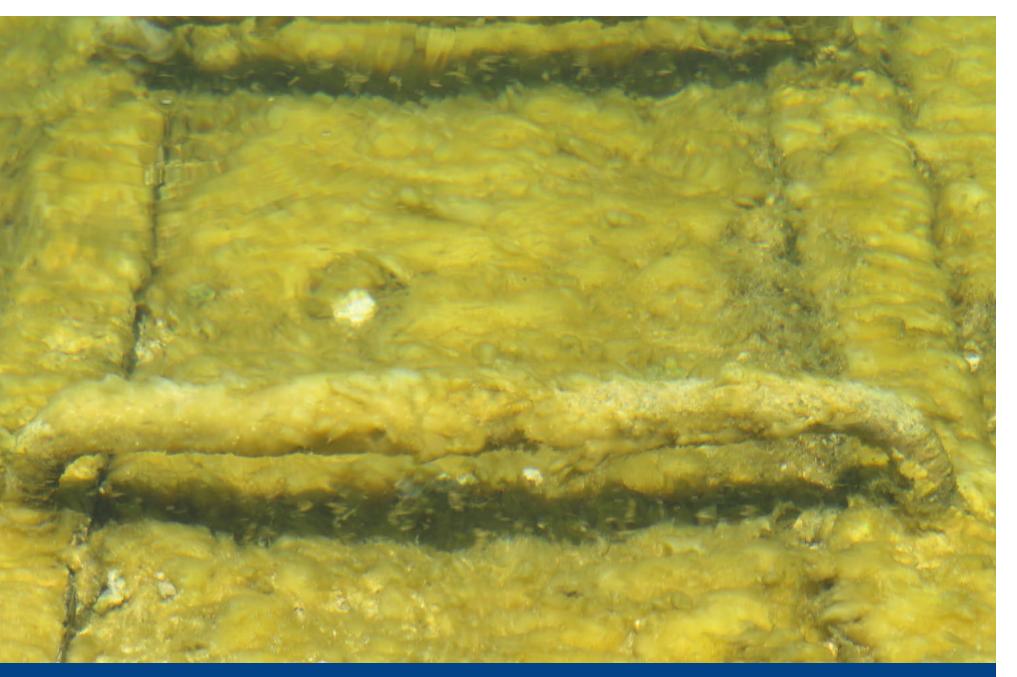
CYMBELLA CAN GROW IN A THICK MASS ON THE CANAL LINER AND COMPLETELY COVER STRUCTURES SUCH AS THIS SAFETY LADDER Photo by Scott Bryan

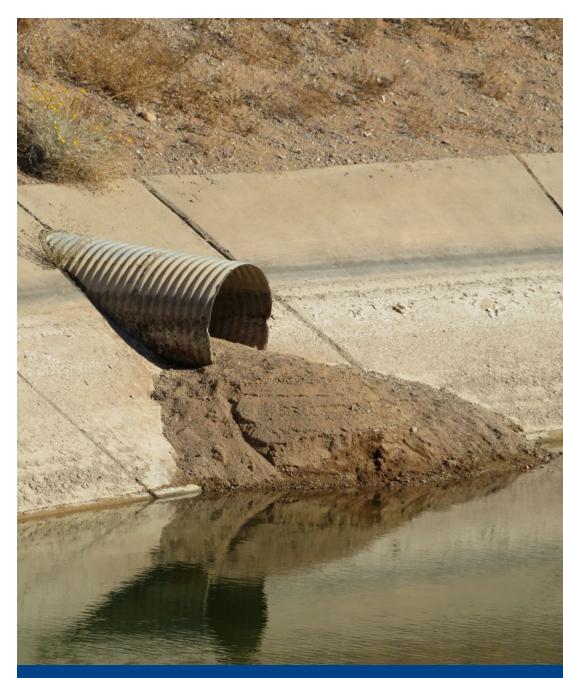
SEDIMENT FROM RUNOFF ENTERS THE CANAL THROUGH DRAINAGE STRUCTURES Photo by Scott Bryan

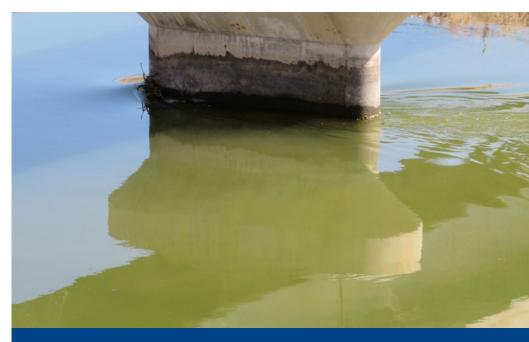
Turbidity in the CAP increased significantly during April 2020 when there was an extended moderate-level discharge from Alamo Dam.
