Case Study: Motor Rotor Cracks

LHQ U10 Rotor
2250 HP Electric Motor

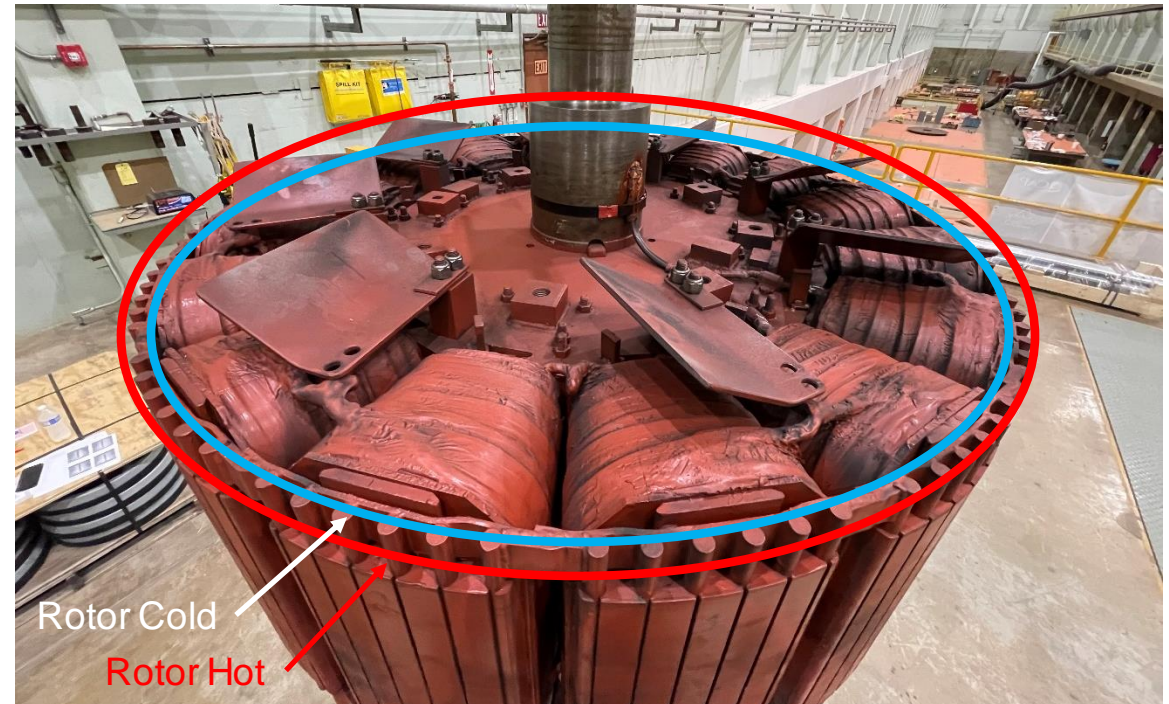
Suspected Cause

- Insufficient OEM Design
 - Connection not sufficient for operating stresses
 - thermal expansion of rotor during operation (20 °C to 60°C)
 - Inertial forces
- Modifications in 1990s not adequate
 - May have introduced residual stresses (counterproductive)

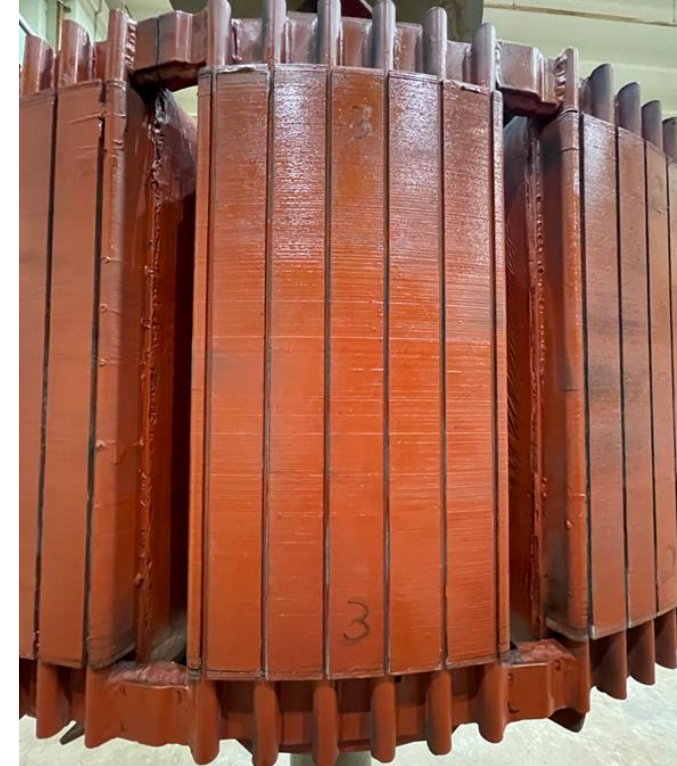
Long Term Risks

- Arcing across broken connections
 - Debris thrown out into the stator end turns, possibly resulting in insulation failure.
- Additional broken connections result in single rotor poles no longer part of amortisseur winding electrical circuit
 - Impact to motor starting times and synchronization
